REDUCTION OF MOISTURE IN BASEMENTS OF BUILDINGS

Martin Prejza, Pavel Kic
Czech University of Life Sciences Prague
cincilap@seznam.cz, kic@tf.czu.cz

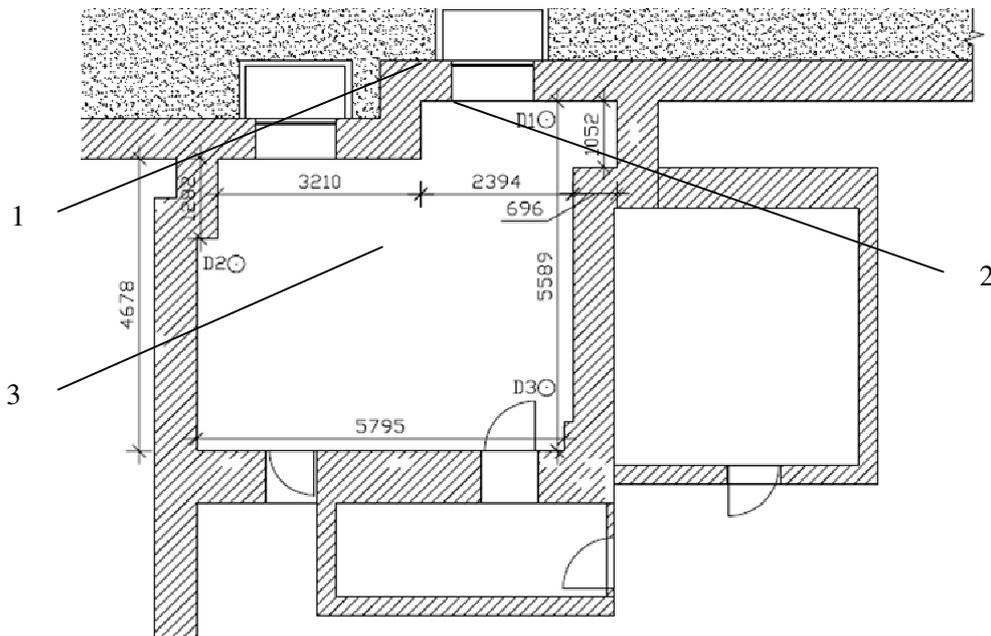
Fig. 1. Subterranean basement room: 1 – external wall; 2 – inside wet surface; 3 – room

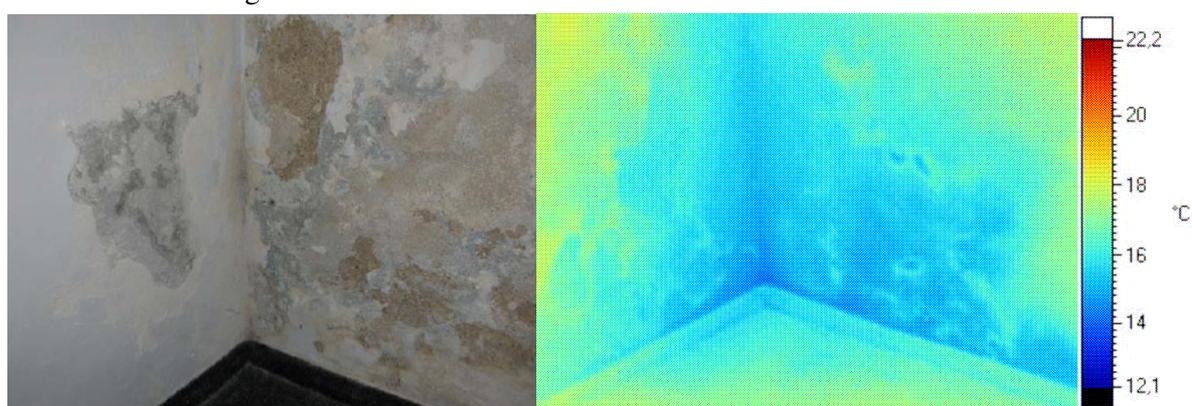
Photo and thermogram of the corner between two walls before reconstruction are given in Fig. 2. High humidity of some parts of the inner walls is also demonstrated at lower temperatures of these walls. The difference in temperatures of various parts of inner surfaces of the peripheral walls is visible on the thermogram.

Fig. 2. Photo and thermogram of the corner between the window wall and side wall

Due to the bad microclimate inside the room there were arrangements made to reduce the influence of the outside wall on the indoor environment. With the aim to make the simplest solution and achieve the lowest cost the original interior plaster was removed and a new protective inner wall (thickness 70 mm) with a ventilated gap between the wet outside wall and the new inner wall was
