COMPREHENSIVE APPROACH TO EVALUATION OF DEGRADATION IN CHOSEN PARTS OF ENERGY EQUIPMENT

Sylvia Kusmierczak, Tomas Majzner

Jan Evangelista Purkyně University in Ústí nad Labem, Czech Republic

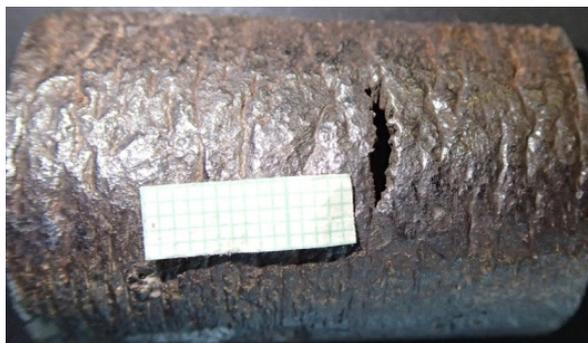
Visual evaluation: on the surface: there was a cohesive failure with a large number of diagonal oriented cracks. The increased roughness, surface geometry and distinct uneven distribution of corrosion products are shown on the tubes, Fig. 1. The damaged inner tube surface is shown in Fig. 2. The crack was initiated on the outside surface, spreading the material towards the inner diameter of the pipe. Even this surface was attacked unevenly by distributed corrosion products.

Fig. 1. TO 1, outer surface of the tube

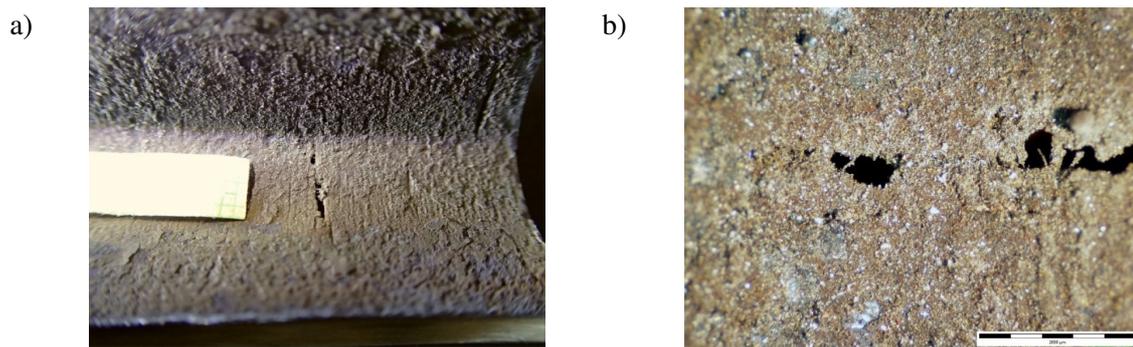
Fig. 2. TO 1, inner surface of the tube: a – crack; b – detail

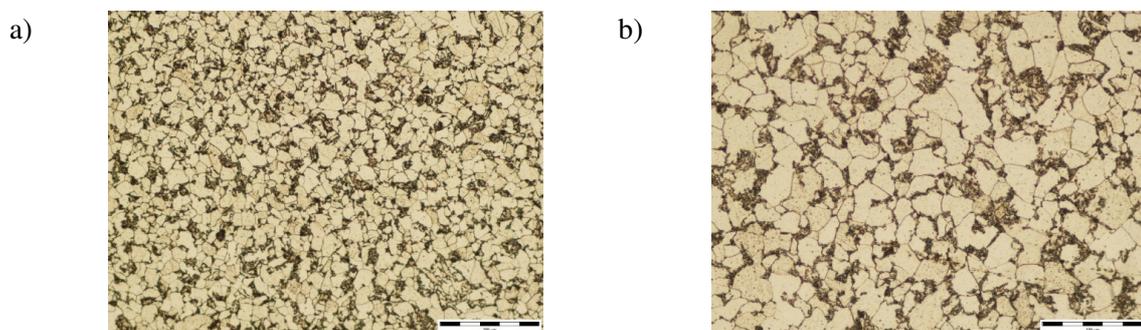
The microstructure of the tube material is formed of ferritic and pearlitic grains, which have a non-uniform size, Fig. 3. It does not match the required heat treatment, namely the state after normalization annealing.

Fig. 3. TO 1, microstructure, cross sectional view of, etching: a – ferritic-pearlitic grains; b – detail

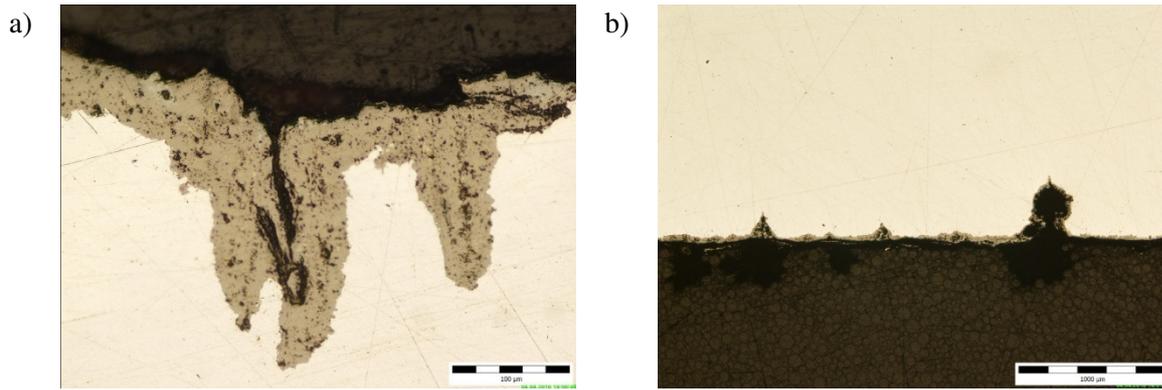
Type breach of the outer and inner surface of the tubes is shown in Fig. 4. The depth of corrosive attack on the outer surface of the material achieves to half the wall thickness. The outer surface of the pipe thus exhibits corrosion attack and exhibits cracks, which are oriented perpendicularly to the propagation direction of the medium in the pipe. The transversely extending cracks are likely to have originated in the corrosive stress conditions in the pipe wall caused by temperature changes significantly when spraying the walls with boiler water. Cracks are tipped with sharp notch, which is covered with corrosion products. In locations cracks occur during pipe expansion and stress concentrations can be expected that the areas thus damaged will cause leakage.

On the inner surface corrosion attack is very small and the maximum depth is max. 0.2 mm. Degradation of the inner surface of the tube was induced by corrosive attack in the form of pitting, Fig. 4 b.

Fig. 4. TO 1, details of corrosive attack: a – the outer surface; b – the inner surface

The internal and external factors were determined for TO 1 that may cause degradation of the object. Based on the analysis it can be concluded that the object damage occurs due to the action of stress and corrosion. As a probable cause of this type of damage appears insufficient dilation and cyclic loading, caused by bad functioning of the cleaning device. In this it caused signs of degradation mainly by external factors – stress and corrosion loading. Recommendation: to remove the cause of degradation of the object, i.e. carry out inspection of adjustment of the water sprayer walls of the combustion chamber.

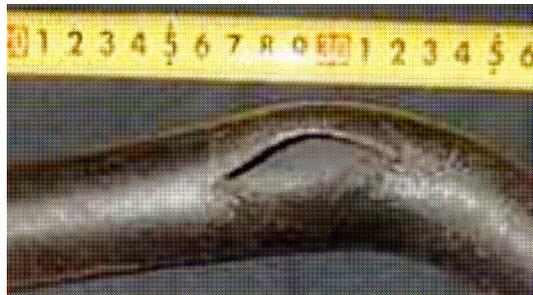
Fig. 5. TO 2

Location and description of the manifestations of degradation TO: gaping longitudinal crack in the medium flow direction. The sample was taken from the evaporator in the pipe bend, Fig. 5.

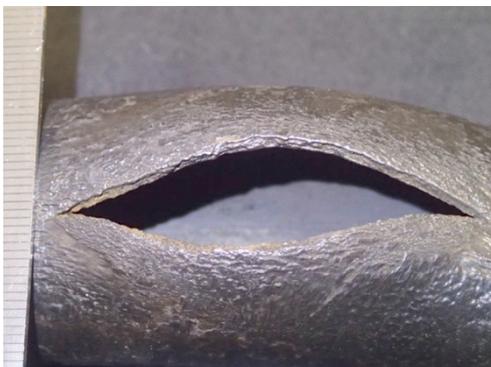
Visual evaluation: The pipe surface was covered with thick layers of slag and all baked. Cleaning surface was seen wrinkling in the longitudinal bending, the crack openings have length 50 mm, width 20 mm, Fig. 6. The wall thickness of the original size of 6 mm changed in the location of the interruption on the surface cohesion on 1.5 mm, Fig. 7.

Fig. 6. TO 2, damaged pipe

TO 2: based on analyzes it can be concluded that the object was damaged due to excessive exposure to stress in the increased thermal stress with a typical course of the crack. Increased thermal stress can be caused by insufficient flow of the cooling medium. In this case it caused degradation signs of external factors – the tension and exceeding the allowed limit for heat stress. Recommendation: places where the pipeline at present has degradation are not possible to locate and even predict the formation of the actual degradation. This is often associated with reductions in the flow of the cooling medium, a result of which there is a significant temperature increase above the acceptable values resulting in the creep of the material and, in the worst case, appearance of cracks and the formation of fracture surfaces. Generally, it is necessary to inspect the flow of the medium in the chamber, from which the water-steam mixture is supplied to the exchanger tubes.

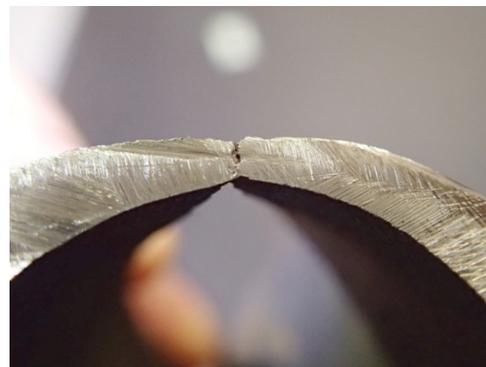
Fig. 7. TO2, changing thickness of pipe

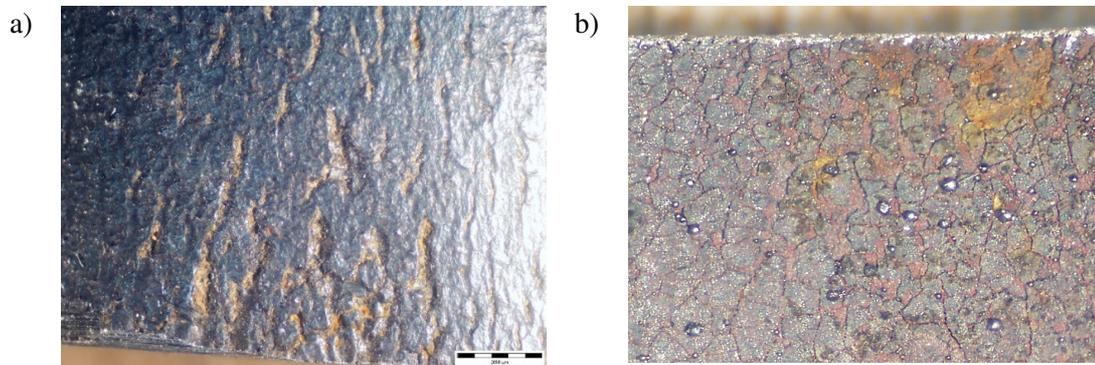
Fig. 8. TO2, tube surface: a – the outer surface; b – the inner surface

Microscopic analysis: Fig. 8 shows the details of the outer and inner wall surfaces of the pipe cracked protective oxide layer. The pipe cross-sectional detail of the damaged oxide layer outside and inside surface is shown in Fig. 9. The thickness of the oxide layers is 0.25 mm on the outer surface, 0.1 mm on the inner surface.

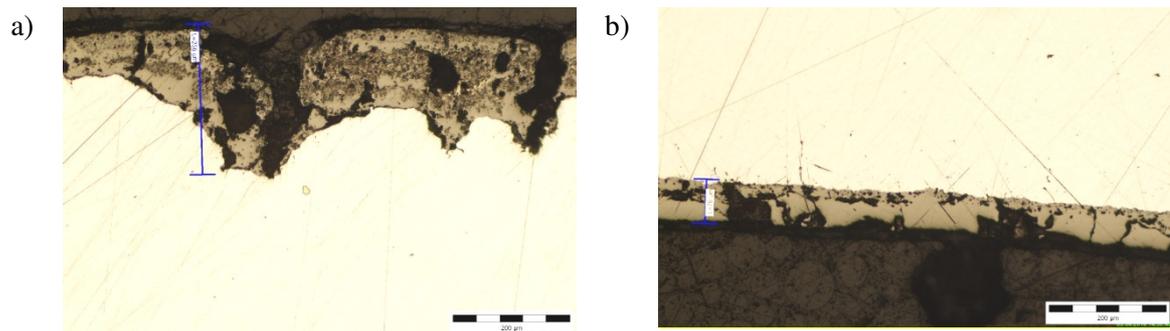
Fig. 9. TO2, cross sectional view of, the oxide layer: a – the outer surface; b – the inner surface

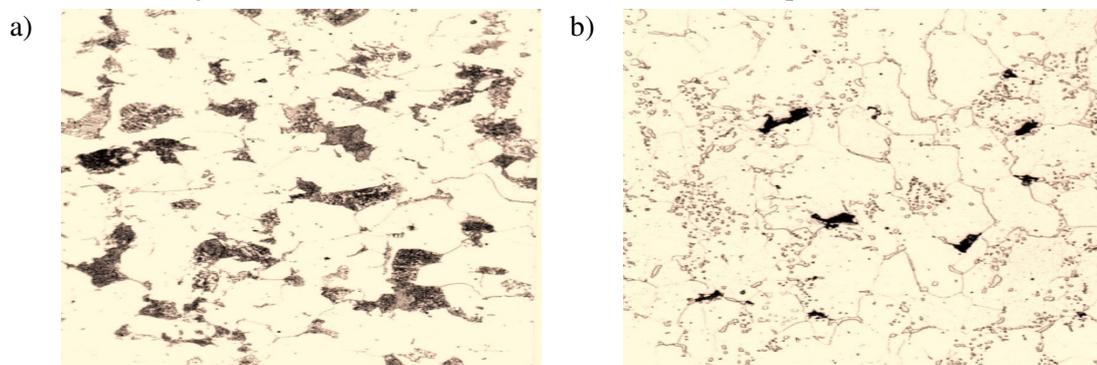
The pipe material has a ferrite-pearlite structure (Fig. 10 a) with a heterogeneous grain sizes. The area of destruction (Fig. 10 b) is characterized by significant structural degradation consisting in breaking the original composite structure to ferrite unevenly distributed carbides. There are cracks visible in cavities at grain boundaries, which are the side effect of creep.

Fig. 10. TO2, microstructure, cross sectional view: a – inner surface, outside the region of degradation, magn. 500x; b – inner surface, in the region of degradation, magn. 500x
