## ASSESSMENT OF RAILWAY TURNOUT ELEMENT RESTORATION USING MMA AND FCAW WELDING

**Dijs Sergejevs, Andris Tipainis**  
Riga Technical University, Latvia  
andris.tipainis@rtu.lv

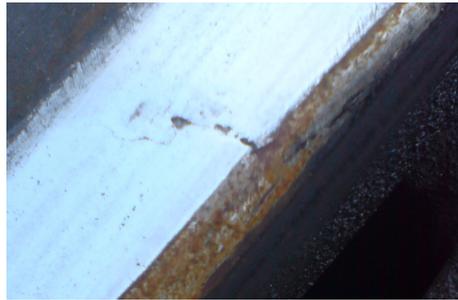
At the beginning of November 2009 LDz staff revealed defects of the turnout No.3 in Garoza station, which had to be eliminated. The management of Jelgava Road distance decided to perform the first built-up welding of the turnout No.3 (which had VARIO frog) on 9 November 2009, where a wing rail with the wear of 3 mm and a 20 mm wide crack, as well as a frog core the wear of 6 mm were renovated (Fig. 1).

**Fig. 1. Defects of the frog core**

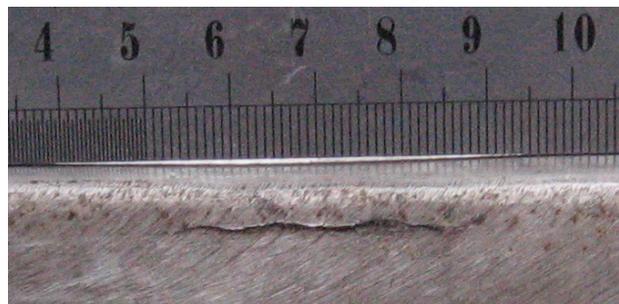
The second built-up welding was performed 95 days after the first built-up welding in order to prevent the longitudinal cracks of the wing rail and core (Fig. 2). On 12 February 2010 the second built-up welding was carried out by applying the same technology and using the same tools and materials, which were used during the first built-up welding.

**Fig. 2. Longitudinal crack after first build-up welding**

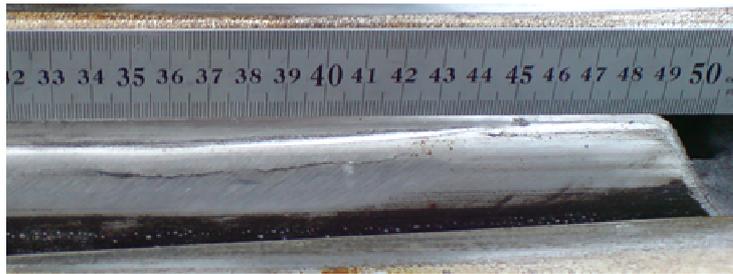
In order to prevent the longitudinal cracks in the frog point and on the rolling surface, the third built-up welding was carried out in this turnout on 23 March 2010, namely, 39 days after the second built-up welding (Fig. 3).

After the third built-up welding just in 13 days the frog core was immediately replaced by a new one because longitudinal, penetrating cracks and shivers appeared in the frog core.

Fig. 3. Longitudinal cracks on frog point after second build-up welding

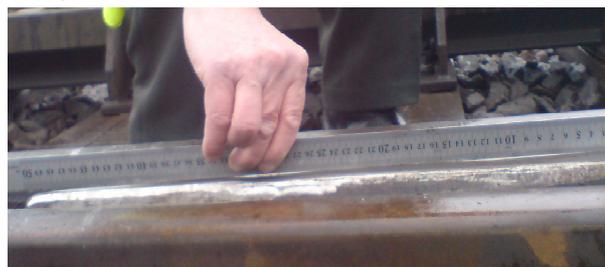
4. While welding the frog core made of steel with a high content of manganese according to the instruction [3], it may not be heated more than 200 °C so that not to change the austenite structure of this steel. By overheating above 200 °C the steel loses its strength, hardness and wells form during the wheel load (Fig. 4).

Fig. 4. Wells formed during the wheel load

8. Non-observance of the grinding temperature. According to the instruction the temperature during grinding may not exceed  $70\text{ }^{\circ}\text{C}$ , especially while grinding the weld of the frog core. However, it was observed that the temperature during grinding reaches  $90\text{ }^{\circ}\text{C}$ . By increasing the temperature above  $80\text{ }^{\circ}\text{C}$  the material of the welded layer loses hardness, due to which wells form under the impact of the rolling stock (Fig. 4).

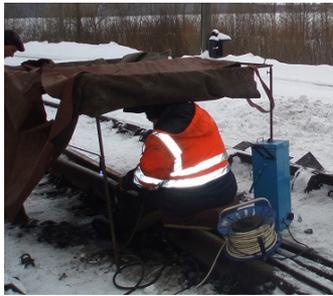
9. During the second built-up welding, which took place in February when the outside temperature was minus  $3\text{ }^{\circ}\text{C}$ , it was snowing and gusty wind was blowing, the welder's post was not protected from the snow covering the welding area (Fig. 5). The humidity in the welding crater is the reason of the presence of oxygen and hydrogen. Oxygen reacts to iron and forms iron oxides, while the hydrogen forms pores by remaining in the welded metal. That all is the reason of appearing of cracks and spalling in the welded layer under the impact of the rolling stock wheels (Fig. 6).

Fig. 5. Insufficient coverage of the welding area

Therefore, the welding area must be well protected with a high quality tent during snow and rain, while the gases releasing during the welding shall be discharged by means of a fan. Gas discharge from the tent is necessary so that the welder could see the welding crater well and had not to breathe gases.

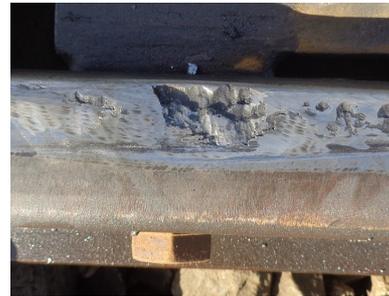
Fig. 6. Spallings in the welded area

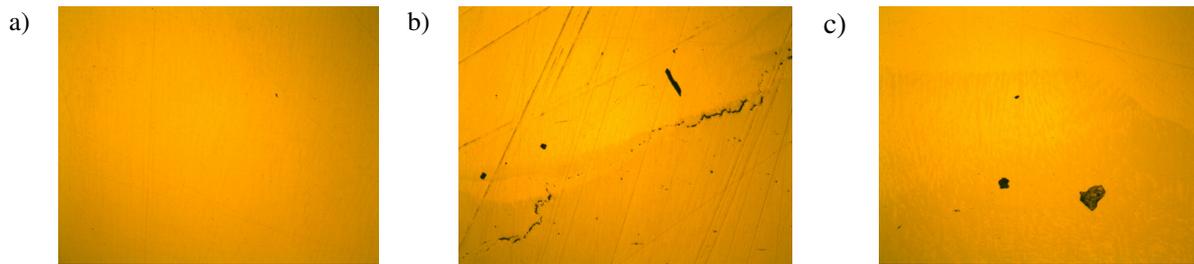
During the metallographic examination it was established that approximately 25 % of the welded layers have poor quality and inclusions, pores, as well as other defects, but in general the welded layers have good quality (Fig. 7).

Fig. 7. MMA welded layers (x100): a – good fusion; b – non-fusion; c – inclusions

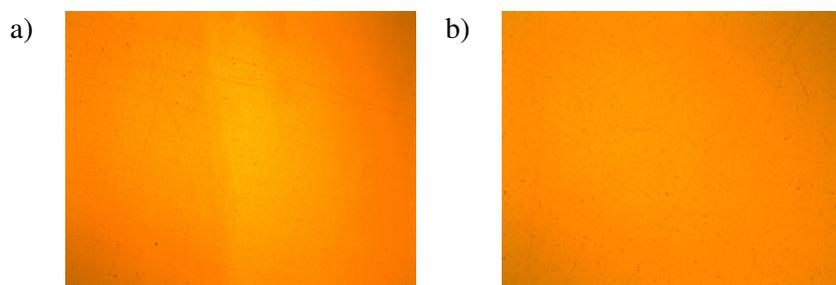
Metallographic examination was conducted for both types of performed build-up: MMA and FCAW, revealing good quality of the weld without inclusions, pores and with good fusion of the welded layer and base metal (Fig. 8). The main prerequisite for high quality build up is precise compliance with the technological process, i.e. maintenance of constant temperature during all welding process. During the experiments with the FCAW method the temperature of the frame rail was constantly monitored and the process was interrupted every time when the temperature decreased to 380 °C. The rail was heated up again up to 400 °C – 440 °C. Considering that this prerequisite was complied with during the experiment, the quality of the weld was very good. Whereas, as evidenced by MMA experiments conducted earlier, if the temperature of the element falls below 300 °C – 270 °C, micro cracks can appear in the thermal heat area and the build-up layer thus causing the defects [7].

Fig. 8. FCAW (with semi automat) welded layer (x100): a, b – good fusion
