DETERMINATION OF CAUSES OF SERIES ER2T ELECTRIC MULTIPLE UNIT TRAIN TRACTION GEAR RUBBER-CORD SHELL DAMAGE

Abstract. The theme of the article was chosen due to a large number of failures of the rubber-cord coupling for traction drive of ER2T series electric multiple unit (EMU) trains. The number of failures was summarized on the basis of the railway company JSC “Pasažieru vilciens”, operating on the Latvian railway, reports on unscheduled repairs for the period from 2015 till 2020. In the presented article we will discuss the determination of the reasons for ER2T series EMU trains rubber-cord coupling failure. The object under study was a rubber-cord coupling, which was out of order and taken after unscheduled repair from a motor car No. 2207-02. Based on the results of the test trial on 23.07.2020, the heating temperature of eight rubber-cord couplings was determined on four carriages of the ER2T series train No. 7115R on the route Riga-Jelgava. The shear stress τ_s and the radial load F_r acting on the coupling during movement are determined. In the RTU laboratory, the geometric dimensions of the coupling have been determined, the influence of the lubricant action and the temper

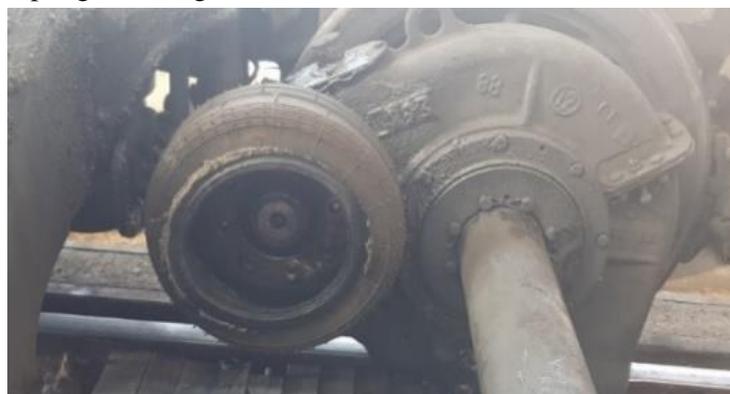
At the company JSC “Pasažieru vilciens” operating on the Latvian Railway, the second most important reason for unscheduled repairs of ER2T series EMU train motor car traction gears is the failure of the rubber-cord coupling shell, Fig. 1.

Fig. 1. ER2T car rubber-cord coupling side surface damage

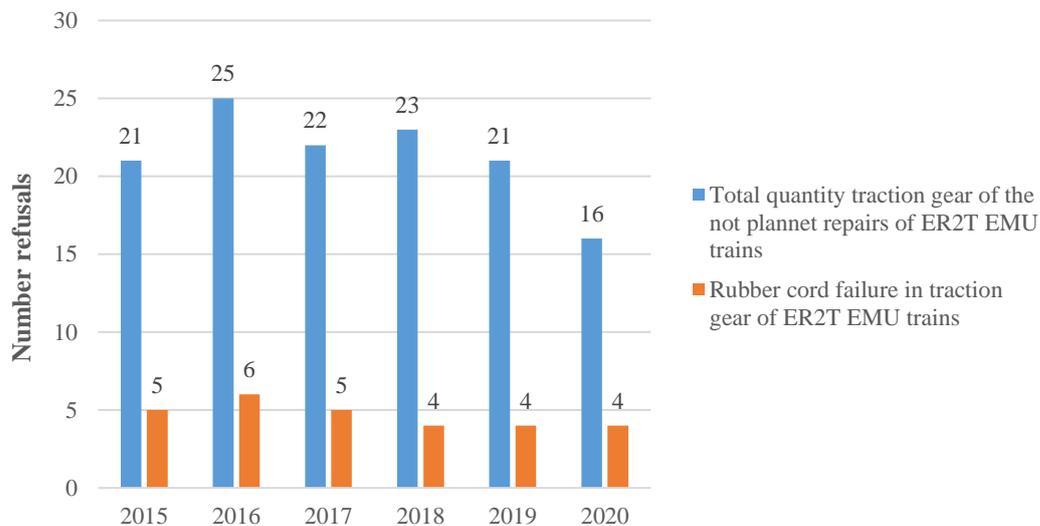
Fig. 2. Number of unscheduled repairs in traction drives and rubber-cord damage 2015-2020

The graph in Fig. 2 shows the total number of unscheduled repairs of the traction drive of the ER2T series EMU trains, in comparison with the total number of unscheduled repairs of the traction drive due to the rupture of the rubber-cord coupling shell. Failures of the rubber-cord coupling are more than 21% of the total number of traction drive failures.

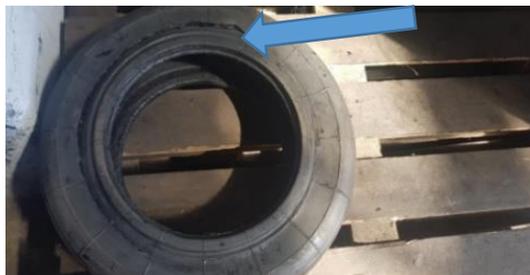
To determine the causes of failures a rubber-cord coupling, removed from the motor car ER2T No.2207-02 after unscheduled repair due to a rupture of the side surface (Fig. 3), was taken for research.

Replacement of the cord coupling according to the repair rules L31/97 [4] should be carried out during the type TR-3 periodical repair in October 2019. The car, after being repaired in the volume of TR-3, was put into operation on October 29, 2019, but already on July 20, 2020, while performing type TA-3 maintenance, a rupture of the side shell of the rubber-cord coupling was noted.

Fig. 3. ER2T 2207-02 damage to the side surface of the ER2T 2207-02 motor car rubber cord

During visual inspection, it was found that on the coupling from the side of the traction motor, at the place of torque transmission, there is a presence of grease on the side surface of the coupling. Cracks

and ruptures of the side surface of the coupling were also found along the entire circumference not far from the place where the coupling was attached to the flange. This type of failure associated with the destruction of the shell in the circular section at the clamping of the flanges is the most common failure of the coupling, and accounts for more than 90% of the total number of failures of the of ER2T series EMU train couplings. According to the mileage reports (PVR4-template) [5] the failure of the rubber-cord coupling occurred when the car reached the mileage of 97598 km. It should be noted that when installing a new coupling, in accordance with GOST 33118-2014 requirements, the mean mileage between failures must be at least 200 thousand km. When analysing the statistical data of the JSC "Pasažieru vilciens" motor cars mileage (PVR-4 template), on which failures of rubber-cord couplings were found, it was revealed that the mean mileage between failures of the couplings was:

1. The first possible reason for failure of the coupling, when reaching the mileage of 97 thousand km, is not timely replacement with a new one during type TR-3 repair, and the coupling was replaced on the basis of its actual condition instead.

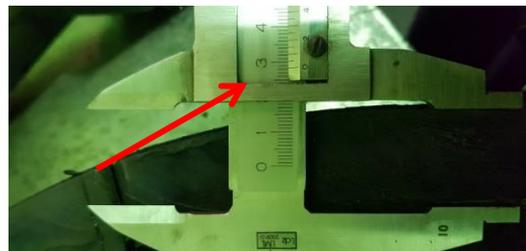
According to the results of the measurements it was stated that the dimensions of the investigated coupling in terms of the diameter of the outer surface and the thickness of the flange do not meet the requirements of GOST 33188-2014. The thickness of the flange was 28.4 mm, Fig. 5.

Fig. 5. Flange thickness measurement results

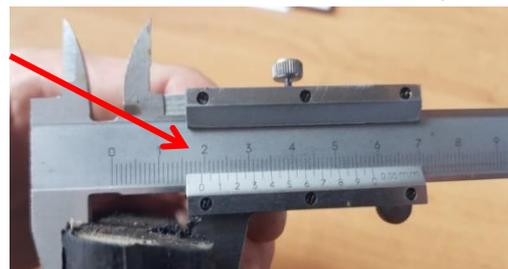
Also, when measuring the side surface of the coupling, it was stated that at the point of attachment of the rubber-cord coupling to the flanges, where the traction force is transmitted from the traction motor, the coupling shell has the smallest wall thickness. According to the measurement results, the side surface of the coupling has the smallest thickness, which was 19.4 mm, Fig. 6.

Fig. 6. Result of measuring the side surface of the coupling at the fastening place

3. When carrying out calculations to determine the shear stress τ_s , it was found that with an increase in the thickness of the coupling shell from 19.4 mm to 21.5 mm, the contact stress at the point of attachment of the coupling decreases from $2.882 \cdot 10^5$ to $2.6 \cdot 10^5$ (by 0.26 MPa). To prevent rupture of the coupling shell at the attachment point, it is necessary to consider measures to increase the thickness of the side surface of the coupling by 10% at the point of attachment to the flanges of the traction motor and the small gear.

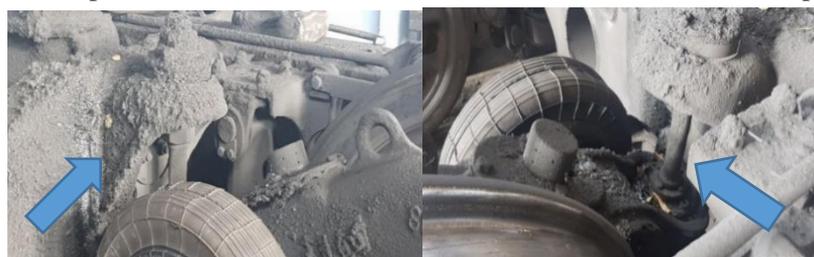
Determination of the effect of “MOL Alugear LKP 000” lubricant and temperature on the hardness of the rubber-cord coupling material. During the operation of the traction gear of the ER2T series EMU trains, as a result of the labyrinth rings surface wear, the gear wheels lubricant MOL Alugear LKP 000 is ejected and, as a result, a part of the lubricant falls on the outer side surface of the coupling, Fig. 7.

Fig. 7. Leakage of grease from the gear unit on the car ER2T 7117-08

5. The fourth reason for the failure of the coupling is the possible effect of lubricant on the outer surface of the coupling shell, as a result of which there is a partial absorption of lubricant by the outer cover layer of the coupling – “swelling”. The increase in the volume of the coupling was ascertained from the results of measurements of the flange thickness, which was 28.4 mm, which by 0.2 mm does not meet the requirements of GOST 30188-2014 standard. Also, according to the results of measuring the hardness by the Shore method, for a sample treated with MOL Alugear LKP 000 lubricant at a temperature of $+ 60\text{ }^{\circ}\text{C}$, it was found that the hardness did not meet the requirements of GOST 30188-2014 standard by 5 con. units, the hardness was 45 con. units.

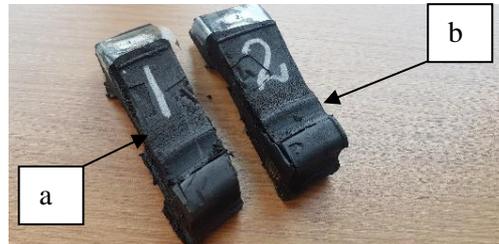
Fig. 8. Samples for determining the influence of temperature and the action of the lubricant:
a – Sample 1, b – Sample 2

4. The third possible reason for the failure of the coupling is the overestimated hardness according to the Shore method at all studied temperatures in the lower part of the samples (that is, in the place where the coupling is attached to the flange). For 1 specimen, the lower part, the discrepancy by

- 1.5 con. units at temperatures $t + 23\text{ }^{\circ}\text{C}$ and $t + 60\text{ }^{\circ}\text{C}$, the hardness was 66.5 con. units. 2 samples – the lower part, not corresponding to 1 unit, the hardness was 66 con. units, at a temperature of $+ 23\text{ }^{\circ}\text{C}$ and 6.5 con. units, at a temperature of $-20\text{ }^{\circ}\text{C}$ and amounted to 71.5 con. units.
