ANALYSIS AND INVESTIGATION ON DEFECTS – DELAMINATION AND SPALLING OF METAL ON ROLLING SURFACE OF RAIL HEAD UNDER CODE X 10.1

Viktors Ivanovs, Pavels Gavrilovs
Riga Technical University, Latvia
viktors.ivanovs_2@rtu.lv, pavels.gavrilovs@rtu.lv

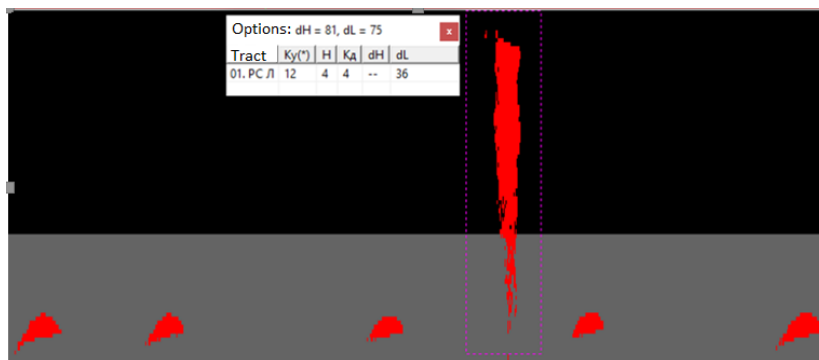
Fig. 1. Decryption of a defect under the code X10.1 using a specialized flaw detection program model 1.4.8, note: In 2011, the primary grinding of the rails was carried out by the “Speno” rail grinding train.

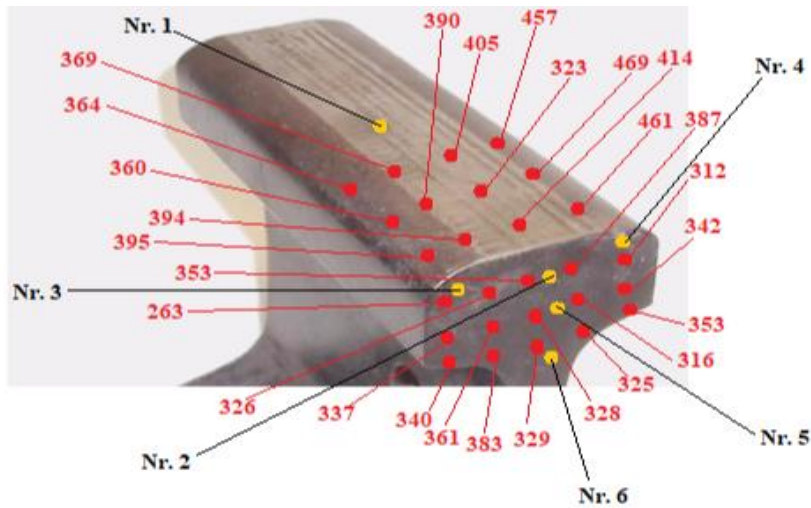
Fig. 4. Determination of the hardness of rail steel with rail type 60 E1T

On the head rolling surface (point 1) HB: 364, 360, 395, 394, 390, 369, 405, 323, 414, 461, 469, 457. At a depth of 10 mm from the head rolling surface (point 2), not less than HB: 326, 353, 387. At a depth of 10 mm from the surface of the rail fillet (points 3 and 4), in HB: 263, 312. At a depth of 22 mm from the rail head rolling surface (point 5) HB: 337, 361, 328, 316, 342. At a depth of 35 mm in the transition of the rail head to the web at (point 6) HB: 340, 383, 329, 325, 353.

The study on the hardness of a defective rail had the following results: the average hardness on the rolling surface of the rail head (point 1) was 400 HB, which is 10 HB higher than the required value. Such hardness is typical for the joint area, due to hardening caused by rolling stock wheel impact at the rail gap [9]. At a depth of 10 mm from the rolling surface and the fillet of the rail head (point 2 - 3 - 4) the average hardness was 328 HB, which is 13 HB less than the required one. It is within this depth that the surface defects of delamination and spalling develop; in our case, the defect was located within this depth. At a depth of 22 mm from the rolling surface of the rail head (point 5), the hardness of the rail steel was 336 HB, which is 15 HB higher than the required value. The hardness of the defective rail at a depth of 35 mm at the transition of the rail head to the web (point 6) was 346 HB, which is 16 HB less than the required one. A carried out study on the hardness of a defective rail showed a decrease in the hardness of the metal at depths of 10 mm and 35 mm.

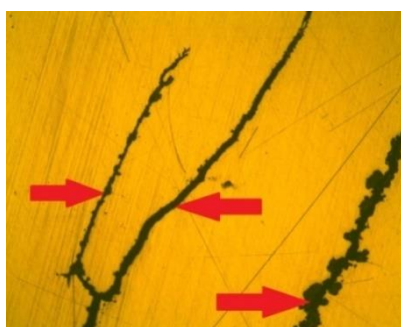
After grinding and polishing the template using a digital microscope “Carl Zeiss Axiovert 40 MAT” at x50 magnification, the structure of the metal of the defective place of the rail head was determined, Fig. 5.

At x50 magnification, the delamination of the rail head in the form of black stripes is clearly visible. The presence of such a branching can lead to a more dangerous acute defect under the code XX30.1 to the horizontal delamination of the rail head [18]. The presence of such cracks in the rail head and the increased dynamic impact from the rolling stock can lead to the puncture of a part of the rail head, which can lead to the derailment of the rolling stock wheelsets. Let us look at the microstructure of the rail. To do this, a defective sample template was etched using a 5% solution of nitric acid HNO₃ [19]. Then this sample was examined under a microscope at x200 magnification, Fig. 6.

Fig. 5. Metal structure of a defective rail T VI 08 60E1 at x50 magnification

5. As a recommendation for extending the service life of the rail head, periodic continuous grinding of the head surface using rail grinding trains can help. Grinding the surface of the rail head will remove surface defects and remove the decarburized metal layer, as well as improve the smoothness of the train ride, extend the life of the track structure and rolling stock wheelsets.

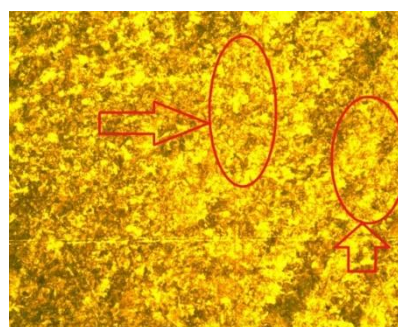
Fig. 6. Microstructure of X10.1 defect at x200 magnification

The microstructure of steel R350HT is ferrite – pearlitic. In Fig. 6 a large accumulation of perlite (red arrows show their accumulation) is visible, which occupies more than half of the total volume. To determine the measurement accuracy and study a defective rail [20] sample under code X 10.1, it was decided to carry out an independent examination at the certified laboratory KIWA JSC “Inspecta Latvia”. According to the results of the examination of the studies carried out in the certified laboratory KIWA JSC “Inspecta Latvia” [15], it can be concluded that the results of the studies carried out in the metallographic laboratory of the Riga Technical University are valid. This confirmation of the results

4. The microstructure of the metal under the microscope confirms the presence of cracks and hairlines in the head of the defective rail, which adversely affect the surface condition of the rail head, which can cause surface defects and their development.
