ANALYSIS OF RAIL PROFILE 610 E1 JOINTS WELDED BY MEANS OF MOBILE RAIL WELDING MACHINE

Abstract. An idea to write this article emerged from the statistics of tracing defects of joints welded with a mobile rail welding machine type No 4 in the Latvian railway during the years of 2014, 2015, 2016 and 2017. The article will discuss a study of the welded joints of rail profile 60 E1, often used both in main line tracks and branch lines of the Latvian railway. The study includes an analysis of defects in the welded rail profile 60 E1 joints in the Latvian railway in eight sections of the line. A question emerges regarding the quality of joints fixed by flash-butt welding by means of a mobile rail welding machine. Once the metal hardness, chemical composition and structure of the rail steel are determined, the quality of flash-butt welding processed joints by means of the mobile rail welding machine type No 4 will be established. The study process comprises four phases. The first phase, determination of Brinell hardness by means of the modern device "Tinius O Olsen" Firmware Version 1.07, FH - 31 Series. The obtained results must be compared with data provided by the manufacturing plant

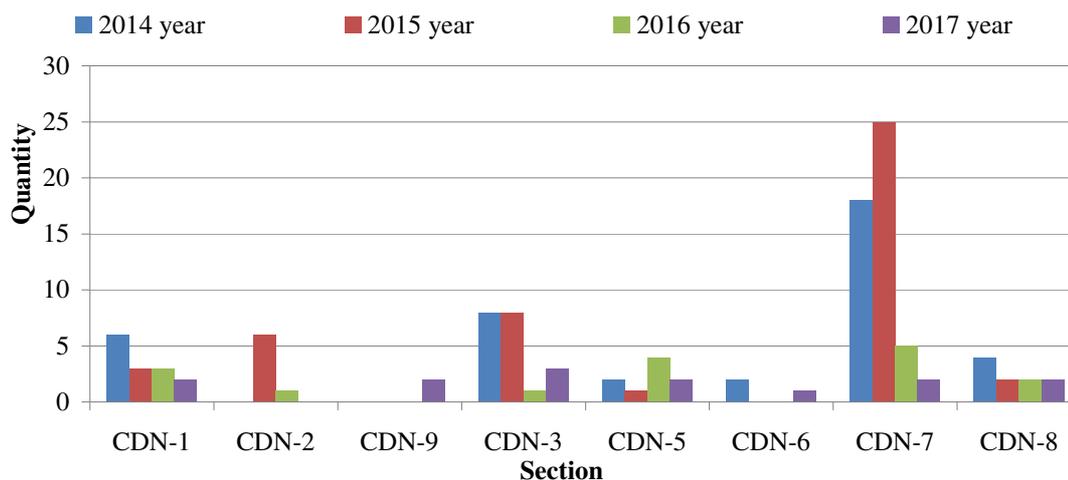
Fig.1. Diagram of highly defective welded joints 2014 - 2017

In 2014 Latvian railway had 40 highly defective rail joints registered, previously repaired with the mobile rail welding machine type No. 4. Number of highly defective rail joints increased in 2015 to 45 cases. Between 2016 and 2017 the number of highly defective welded joints reduced from 16 to 14 cases (Figure 1).

As we know, a fracture of a welded rail joint can result in derail of pair of wheels and also a rolling stock accident. On the basis of statistical data it was decided to study joints welded by means of the mobile rail welding machine type No 4, rail profile 60 E1 T 06 08 on running line Menta - Taurkalne, 250 km, 1st railway milestone. It turned out that present problem is also topical in other countries. Highly defective welded joints are commonly identified partly in Russian and Belorussian railways “BZhd” [5]. Figure 1 shows a quantitative diagram of highly defective welded joints in Latvian railway.

The following conclusions can be made on the basis of the diagram (Fig. 1): the largest number of welding defects in 2014 was identified in CDN-7 Liepāja branch (18), while in CDN-2 Čiekurkalns branch and CDN-9 Rīga branch no defects were found. In 2015 the largest number of defects (25) was still found in CDN-7 Liepāja branch, and in comparison to the year of 2014 it saw increase of 7 defects. In 2015 no defects were established in the welded joints of CDN-9 Rīga branch and CDN-6 Ventspils branch. In 2016 the number of welded joint defects decreased partially in CDN-7 Liepāja branch, amounting to merely 5. Similarly as in 2015, also in 2016 no defects in joints welded with the mobile rail welding machine type No 4 were discovered in CDN-9 Rīga branch and CDN-6 Ventspils branch. During 2017 the number of identified welded joint defects saw significant drop amounting to merely (3) defects in CDN-3 Daugavpils branch, and no welded joint defects were found in CDN-2 Čiekurkalns branch.

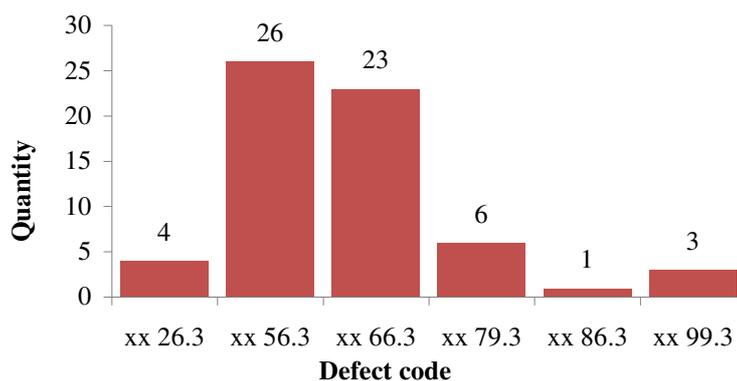
Fig. 2. Quantitative statistics of welded joint defects in network maintained by publicly traded company RZhd

Analysis of statistics on welded joint defects in the railway network of a publicly traded company RZhd [4] revealed that the largest number of defects is identified under codes 56.3, 66.3, 79.3 and 26.3. Defects under codes 99.3 and 86.3 are also predominant in Russian and Belorussian railways. Quantitative distribution of the welded joint defects (according to defect drawings) in the publicly traded company RZhd is presented in Figure 2.

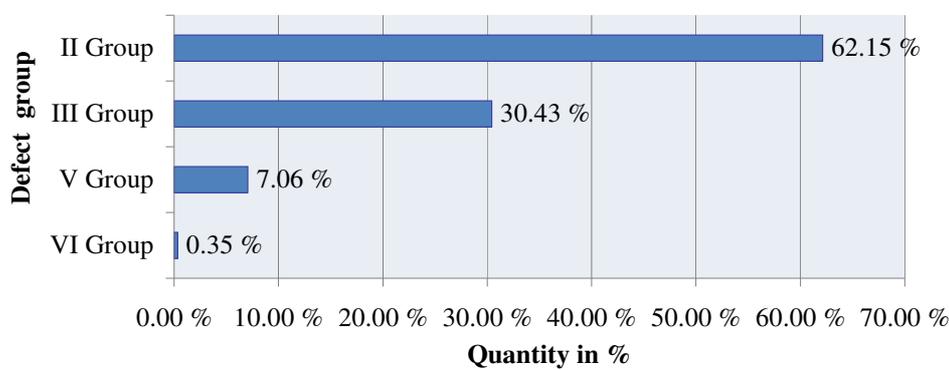
Fig. 3. Diagram of distribution of highly defective rails identified by Belorussian railway inspection shops in 2015

Another urgent problem in the Belorussian railway is highly defective rail identified by the inspection shops. Figure 2 shows % diagram of highly defective rails by groups [5]. Defect groups are as follows:

- group 2 – transversal fissures in the top and resulting fractures;
- group 3 – axial, horizontal and vertical fissures in the top;
- group 5 – web defects and damage;
- group 6 – top defects and damage.

Large part of highly defective rails in “BZhD” network consists of Group 2, amounting to 62.15 % of total amount of flaws identified by the inspection shops of the Belorussian railway [5]. On the basis of classification of C-010 defects of Group 2, these flaws are transversal fissures in the top due to violation of rail welding technology under code 26.3.

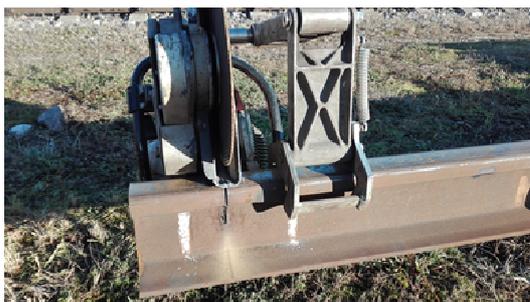
Fig. 4. Process of cutting out piece of welded rail with rail saw

The second phase of testing involved an analysis of the chemical composition of metal in three points of the welded rail (top, web, base). A specimen was cut out with a rail saw from the welded rail joint to be tested. The specimen was polished with a grinding machine to have mirror-like surface (Fig.6).

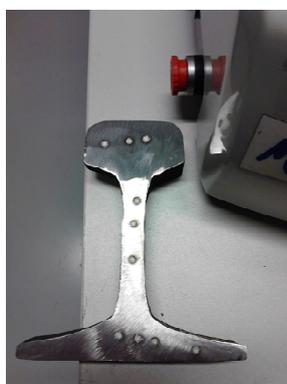
Fig. 6. Determination of chemical composition in three rail components (top, web, base)

The chemical composition of metal was determined with the optical emission spectrometer **PMI – Master PRO**, relying on the principle of local burnoff in the specimen's surface followed by determination of the chemical composition and summing up and printing the obtained data [3]. Measurements were done in three different points, three separate times, in the top, web and base of the rail. Average results of the chemical composition analysis of the specimens are presented in Table 3 and Table 4.

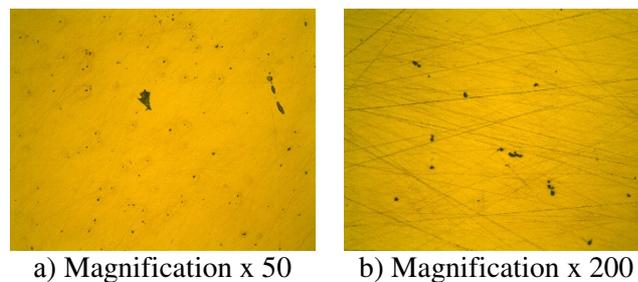
Fig. 8. Determination of metal structure under microscope at various magnifications

The third phase of the study determined the rail steel structure with a modern electron microscope Carl Zeiss Axiovert 40 MAT, and the obtained data were entered in computer. Before determining the metal structure, the specimen's surface was corroded with 5 % solution of the nitric acid HNO_3 [1]. The structure of the first specimen was determined under the microscope at magnification (x50) and (x200) without corroding the metal. The second specimen was analysed at magnification (x50), (x200) and (x500), and was corroded.

The obtained test data are reflected in Fig.8 and Fig.9 and they allow us to draw the main conclusions about the quality of rail steel welded with the mobile rail welding machine. The obtained data show small impurities as black spots in the metal structure. It also confirms presence of insignificant amounts of phosphorus and sulphur in the tested chemical composition. When comparing the metal structure at magnification x 50 (a), x 200 (b) and x 500 (c), insignificant amounts of different impurities are discovered. The structure of present metal is ferritic. Ferritic structure includes compound of ferrous oxide Fe_2O_3 with more basal oxides of others metals that are ferrimagnets, the base component of iron alloys, presented in the solid carbon solution and alloying elements. It has a volume-centric cubic crystalline grid. It is a phase component of other structures, for example, perlite, comprised of ferrite and ferric carbide. If the temperature exceeds 1401°C in iron-carbon metal it forms solid carbon solution that can be considered as delta ferrite.

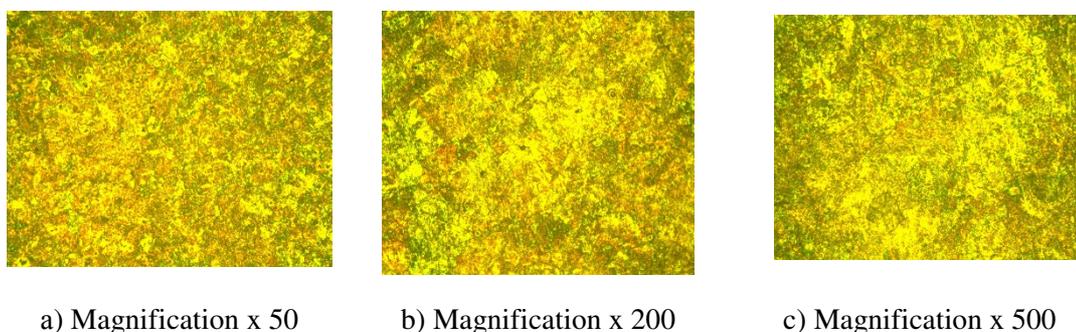
Fig. 9. Determination of metal structure under microscope, corroded with nitric acid (HNO_3) and at different magnification

The structure of the rail steel is ferrite with small inclusions of the form of dark spots. Perhaps, these are the harmful impurities of sulfur and phosphorus, which also confirms the study of the chemical composition. Such a definition of the metal structure is established and defined in different countries of the world in particular the USA, Lithuania, and Estonia.
