HARDNESS TESTING AND CHEMICAL COMPOSITION ANALYSIS OF ER2 AND ER2T SERIES EMUS TRACTION TRANSMISSION RUBBER-CORD COUPLING BOLTS

Pavels Gavrilovs, Dmitrijs Gorbachovs
Riga Technical University, Latvia
pavels.gavrilovs@rtu.lv, dmitriy31@mail.ru

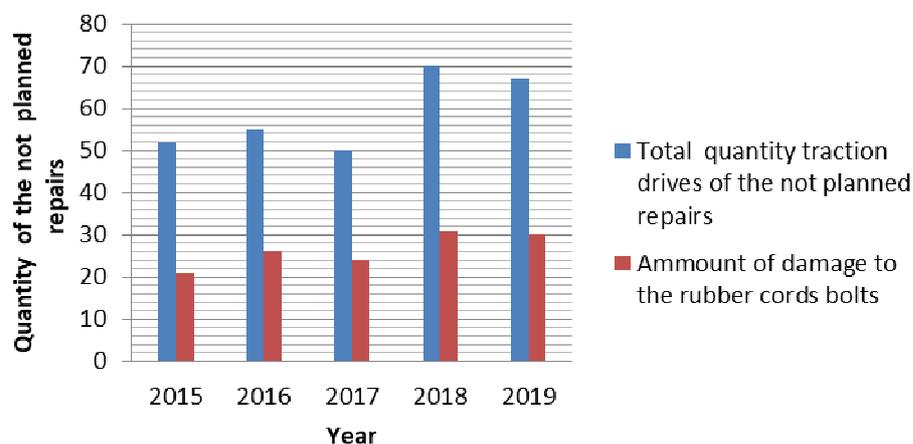
According to Pasažieru vilciens, between 2015 and 2019, 294 cases of unplanned repairs of motor carriages due to traction gear malfunctions were recorded. From these cases, there are 132 bolt assemblies M-24 for attaching the rubber cord coupling [4]. The analysis of the statistical data is shown in Fig. 1. The graph shows the total number of unplanned repairs of the traction gears, compared with the total number of unscheduled repairs of the traction gears due to cracking of the rubber-cord coupling bolts. The total downtime of all motor carriage for the year, when performing an unplanned repair of the traction gears associated with replacing of the bolts of the rubber-cord

1. Fig. Number of unplanned repairs in the traction gear and damage to rubber-cord bolts

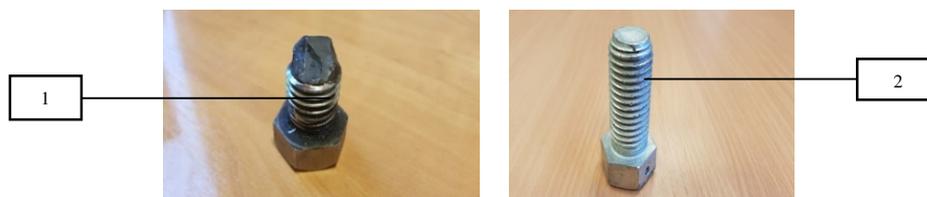
For these purposes, two bolts were taken, one broken (Fig. 2.1.), the second new (Fig. 2.2), removed from the motor carriage ER2 8029-02. It should be noted that the replacement of the bolts on the ER2 8029-02 carriage was carried out at the TR-3 current repair in September 2018, and in November 2019 one of the 8 rubber-cord coupling bolts broke. It should be noted that the mileage of this carriage from the moment of installation to the kink was 169836 km.

Fig. 2. Rubber-cord bolts, samples M-24: 1 – broken bolt; 2 – new bolt

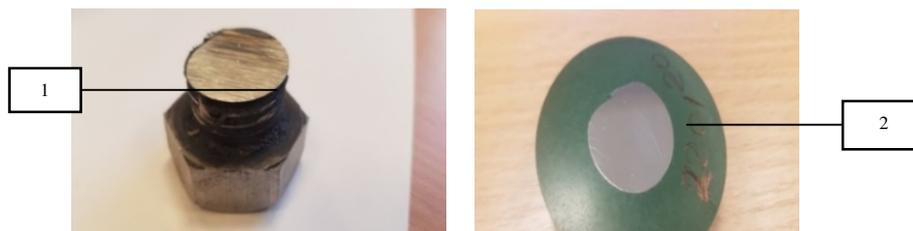
At the second stage of the study, a test was performed in the laboratory of the Riga Technical University for steel hardness, according to the Brinell scale (HB) (Fig. 3- 3.1 – broken bolt; 3.2 – new bolt). The measurements were carried out using the modern instrument “MIC 10” at five points of the crease and the new bolt. The results of the measuring Brinell hardness (HB) are given in Table 1. The results were compared with the data of GOST 4543-71.

Fig. 3. **Determination of the hardness of the bolt:** 1 – broken bolt; 2 – new bolt

2. The hardness of the broken and new rubber cord coupling bolt was determined. According to the research results, it was revealed that in the first sample (broken bolt), the average hardness was 249.2 HB, which is 20.2 HB higher than the requirements of GOST 4543-71. The average hardness of the second sample (new bolt) was 301.4 HB, which also exceeds the permissible value of GOST 4543-71 by 72.4 HB. According to GOST 4543-71, the hardness of the steel should be 229 HB. The increased hardness, with a high degree of probability, could affect the specimen crease, since with increased hardness the material of the sample starts to work as brittle, since during the initial inspection of the cracked bolt, traces of delayed brittle fracture, which was under a load close to the yield strength, were found.

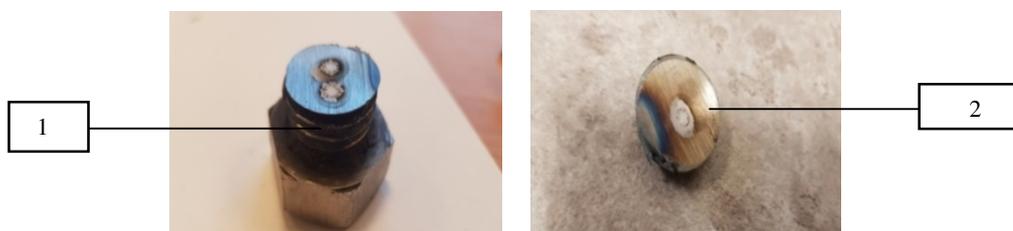
At the third stage of the study, the chemical composition of the metal of the broken bolt and the new bolt (Fig. 4) were analyzed. To determine the chemical composition of the metal, we used the PMI optical emission analyzer - Master PRO, working on the principle of local burning of the sample surface with subsequent determination of the chemical composition and output of the obtained data to a printing device. The results of the analysis of the chemical composition of the sample are shown in Table 2.

Fig. 4. **Determination of the chemical composition of a bolt:** 1 – broken bolt; 2 – new bolt

According to the results of the chemical analysis, the material grade of the broken bolt corresponds to the steel grade C30E-Sk30, and the new bolt – steel grade 34Cr4. The obtained data of chemical elements were compared with GOST 4543-71. The results of the analysis of the chemical composition of the samples are shown in Table 2.

3. According to the results of the chemical analysis, the chemical composition of the broken bolt and the new bolt was determined. It was also stated that in this sample there is a small amount of harmful impurities of phosphorus and sulphur, which does not exceed the permissible norm for this steel grade. It should be noted that the chemical elements, both carbon (C) and chromium (Cr), are below the norm and are only 0.361 for carbon for the first sample and 0.366 for the second sample instead of 0.41-0.49, for chromium for the first sample 0.047 is below the norm, instead of 0.80-1.10. As it is known, underestimated carbon content leads to a decrease in the strength of steel, and chromium increases the hardness and strength of steel. It can be assumed that the second reason for the break of the bolt was the low chromium and carbon content, which did not comply with GOST 4543-71.
