USAGE OF TECHNICAL EQUIPMENT IN TEACHING TECHNICAL SUBJECTS

Sylvia Kusmierczak

Jan Evangelista Purkyně University in Ústí nad Labem, Czech Republic

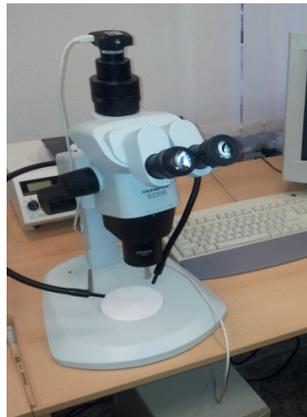
Fig. 2. Optical microscope Olympus SZX10

The accuracy of the performed analyses influences the level of technical equipment. Therefore, in practical lessons students have the opportunity to use modern equipment. The most frequently used equipment will be further described. For macroscopic evaluation there are available: a digital camera with lighting and a microscope that works with magnification max. 50x, it is connected to the PC with software for processing the obtained image.

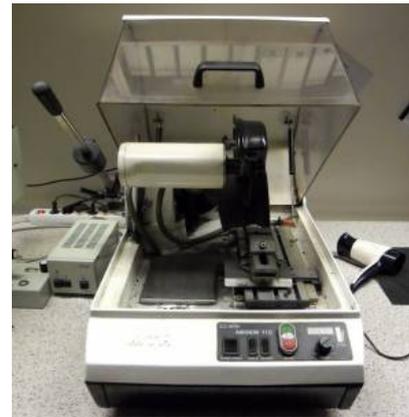
Fig. 3. Metallographic saw MTH Mikron 110

For metallographic sample preparation a metallographic saw, metallographic press, grinding and polishing machine are used. After polishing the sample is often etched with etchants selected, the sample can be monitored by light microscopy. Of course, if necessary, the sample can be observed in the non-etched state. The students most often carried out microstructure analysis on the confocal laser microscope Lext OLS 3100 or optical microscope Olympus BX51M. This equipment belongs to the most used during practical lessons, Fig. 1-8.

Next metallographic preparation of the sample in order to observe the microstructure of the material followed. The first operation was cutting the component, using a circular saw MTH. After creating a sufficiently small portion the press was used. The following operation was grinding by the laboratory horizontal grinder MTH 1031 COMPACT. Students used abrasive papers with different grain sizes. Polishing with abrasive pastes with different roughness followed. The final operation was etching the sample.

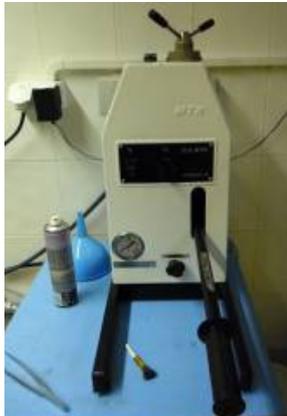
Fig. 4. Press MTH Standart 30

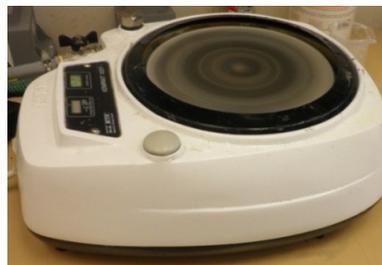
Fig. 5. Grinding and polishing machine MTH Kompakt 1031

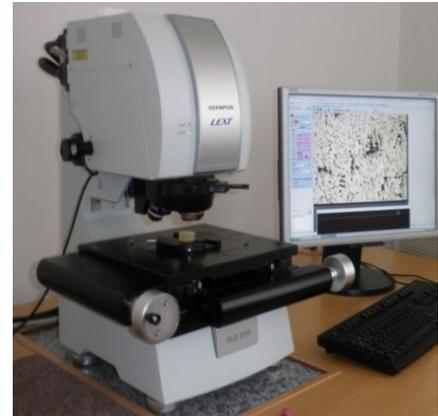
Fig. 6. Olympus Lext OLS 3100

Microscopic analysis was carried out on a confocal microscope LEXT OLS 3100. It has been shown that the basic material in the area of the fracture has a high concentration of inclusions (Fig. 12), which worsen the properties of the material. In fracture profile oxide membranes occur, Fig. 13, which are formed in the material during casting.

After etching the components were observed using the confocal laser microscope Lext OLS 3100. The material has degraded parts of the ferrite-pearlite structure, Fig. 14, 15, consisting of polyedral grains. Locally it can be observed that the material was cold-rolled, the structure was heterogeneous.

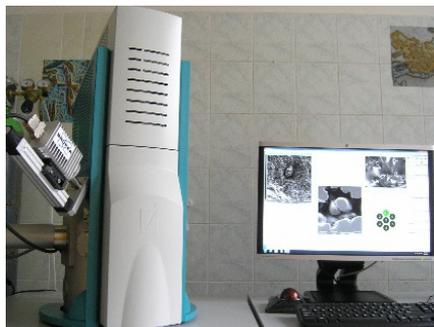
Fig. 7. Electron microscope Tescan Vega 3

The last step was the fractographic analysis of the fracture surface (Fig. 16) with an electron microscope Tescan Vega of 3. This allowed the students to view the fracture surface with a large depth of field.

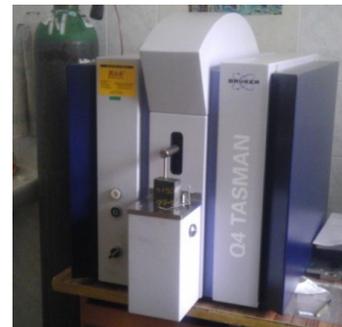
Fig. 8. Spectrometer BRUKER Q4 TASMAN

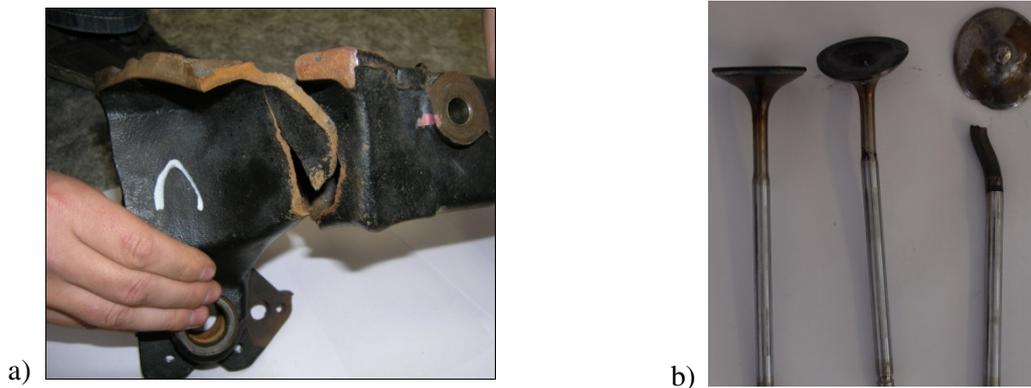
Fig. 9. Examples of the analysed components: a – part of the car chassis, fracture; b – valves, creep

In the subject “Construction materials and limit states” students carried out analyses of the causes of limit states and degradation in different elements of design, Fig. 9.

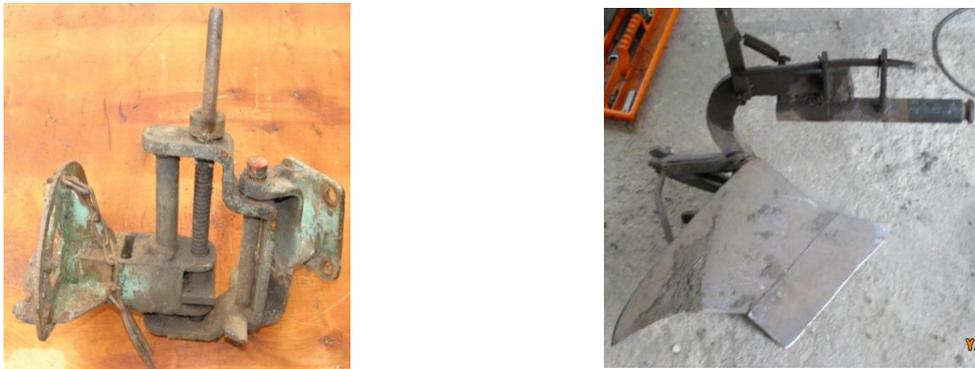
Students decided to analyse the damaged articulated bearing, specifically the tiller, which served to connect the truck to the universal milling machine. The analysed part was damaged at the point where a section was weakened by drilling. As the first step, students documented the current status of the component, Fig. 10.

Fig. 10. Documentation of the degraded part

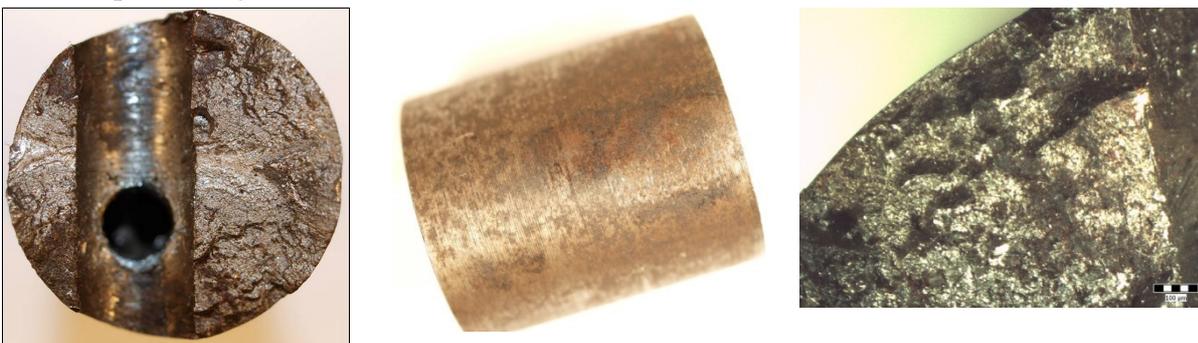
The second step was to make a macroscopic analysis in the area of the fracture and on the surface of the component, Fig. 11.

Fig. 11. Macroscopic observation

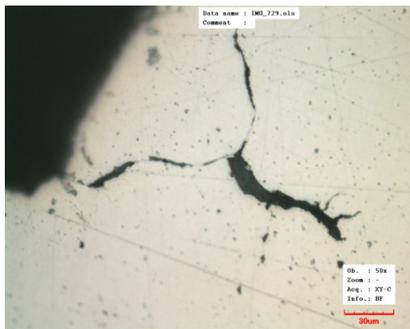
Fig. 12. Oxide membranes, inclusions

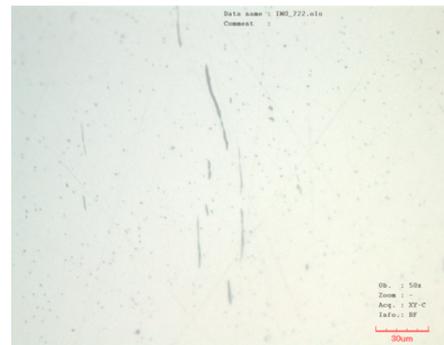
Fig. 13. Sulphide inclusions

Sulphide inclusions formed bands, which relate to the method for manufacturing. Such oriented inclusions substantially reduce the plastic properties of the material.

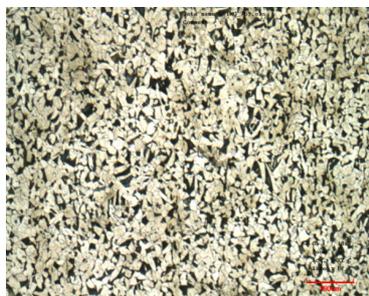
Fig. 14. Structure of the material

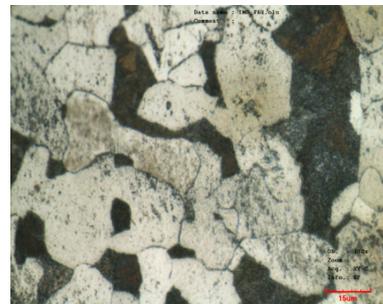
Fig. 15. Detail of the material

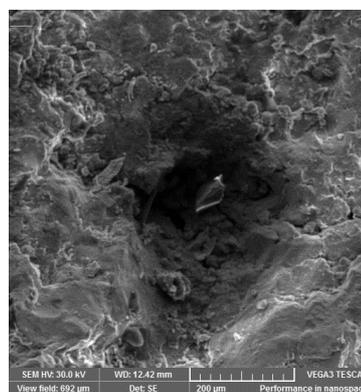
Fig. 16. Fracture surface

This allows describing the morphology of the fracture surface, carrying out chemical analysis of the selected phases using EDX. The analysis confirmed the assumption of the microscopic analysis that the inclusions on the fracture surface are sulfides on the basis of MnS.
