RESEARCH IN PASSENGER CAR BOGIE CENTRAL SUSPENSION ROLLER AND ROD BASE METAL AND WELDED METAL STRUCTURE

Pavels Gavrilovs¹, Aleksandrs Dmitrijevs²

¹Riga Technical University, Latvia; ²Transport Accident and Incident Investigation Bureau, Latvia
pavels.gavrilovs@rtu.lv, aleksandrs.dmitrijevs@taiib.gov.lv

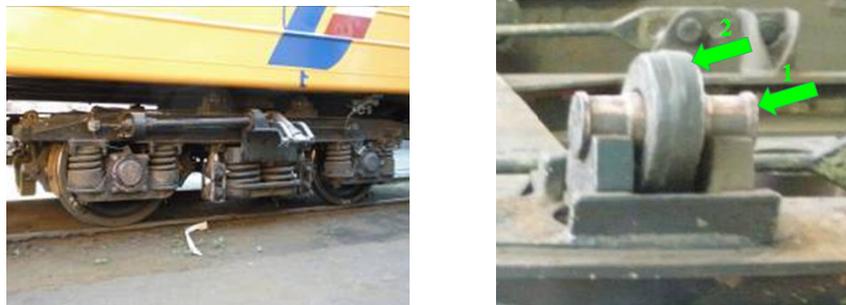
Fig. 1. **Suspension parts:** 1 – roller; 2 – central suspension rod

In view of that this work describes the passenger car bogie, as the study objects parts of the central spring suspension were selected, namely the roller and rod respectively pos. 1 and 2 in Fig. 1 which are working together. As the scope of the research has been selected the hardfacing recovery process of these parts during the repairs on the Repair Company “L-Ekspressis” ltd, which in the Republic of Latvia is concerned in repair of passenger cars operated in long-distance.

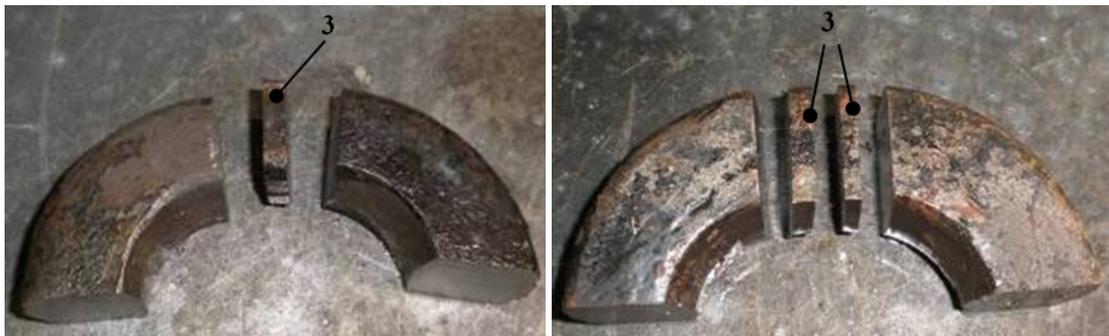
Fig. 7. **Rod of the central spring suspension:** 3 – cross sectional slice of rod with wear (left);
3 – sectional slice of repaired rod (right)

In the rods cut has been executed in the most loaded section 3 Fig. 7.
