REASONS FOR RAILWAY WEAR AT CURVES

Anna Ancevska¹, Dijs Sergejevs²
 Riga Technical University, Latvia
 annaancevska@inbox.lv, dijs@dztu.edu.lv

Abstract. On average in Latvia small radius curvilinear railway sections make up approximately 25 % of the entire network length. An especially urgent problem is ensuring train traffic safety due to premature failure of rails at small radius curves. Analysis shows that the lifetime of rails at curves significantly decreases in comparison to the normative lifetime due to intensive side wear of the outer rail and rapid development of dangerous defects of the head of the inner as well as outer rail. In the article, the results of the analysis of the reasons for premature wear of rails at small radius curves on the Latvian railway are discussed and ways of increasing their lifetime are proposed. In order to analyse the reasons for premature wear of rails, a one-way section of the span Sece - Sēlpils was studied.

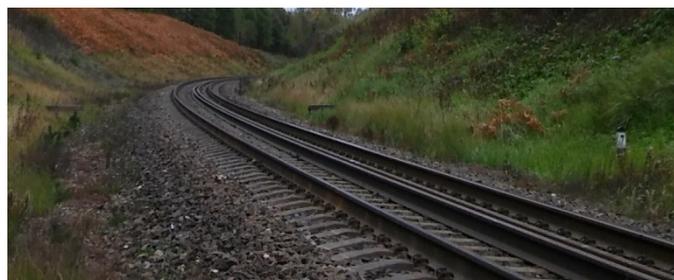
The condition of the rails at curve No. 1 was examined (Figure 1, Figure 2). The curve in the direction from Krustpils is located on an elevation with the downgrade from 3.5 ‰ up to 6.8 ‰ (other small radius curves – on an inclination). The traffic in gross weight comprises more than 25 million tons a year; according to the norms of the Latvian railway, the maximum side wear for the rails installed at this curve (type R-65) with the given load is 15 mm.

Fig. 2. Curve No. 1 on the line Sece-Sēlpils 274.5885 km to 275.2570 km;
 $R = 640 \text{ m}$; outer rail elevation $h = 90 \text{ mm}$

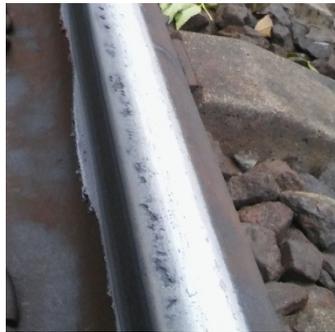
In order to determine the reasons for intensive wear of the rails at curve No. 1, their condition was analyzed from January 2014 to 1 October 2015. The side wear of the rails at this curve during the period of observation reached 16 mm (Figure 3) forming a shelf (which is characteristic of rails with more than 10 mm side wear).

Fig. 3. Outer rail of curve No. 1 with side wear

One of the main reasons for the intensive wear of the rails at the examined curves, according to our calculations, is the high elevation value of the outer rail – h , which is calculated based on the traffic speeds of passenger trains. In reality, only freight traffic is planned at these sections, which is executed at significantly lower speeds. Therefore, the outer rail elevations – h at these sections at actual traffic speeds must be lower. An example of a calculation of the necessary elevation value of the outer rail at curve no. 1 is shown below (Figure 1) based on actual train traffic speeds. For this purpose, using a speed-measuring tape, the actual freight train traffic speeds were analyzed in odd and even directions. On average, the actual speeds of locomotives 2M62 and 2T10M with loaded tank-cars in the odd direction with the average mass of 4750 t at curve no. 1 were 27 km·h⁻¹. The actual average speeds of locomotives of the same series with empty cars in the even direction with the average mass of 1500 t at curve no. 1 were 32 km·h⁻¹.

1. At present, the actual train traffic speeds are not taken into account when calculating the outer rail elevation at small radius curves at freight train traffic sections. The calculation performed based on the actual freight train traffic speeds shows that the existing elevations of the outer rail at small radius curves are significantly higher (90 mm) than the calculated ones (20 mm) This causes uneven distribution of load to the rails, which is one of the main reasons for premature wear of rails at curves of the Latvian railway.
2. Calculation of the elevation heights of the outer rails at small radius curves based on actual average traffic speeds and at other sections of the Latvian railway tracks is recommended.

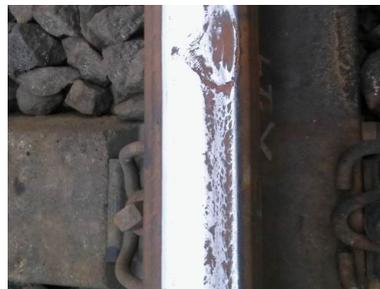
On the surface of the head of the inner rail, peeling and spalling of metal is observed (Figure 4).

Fig. 4. Inner rail with defect on the surface of the head
