FAILURE EXAMINATION OF DISK HEADER WORKPOINTS USING CAE-SYSTEM APM WINMACHINE

Abstract. The scientific work is devoted to search for failure reasons of disk workpoints applying CAE-system APM WinMachine. The purpose of the research is to find the causes of sudden destructions of the disk header's spring tines and to search for constructive solutions for prevention of the detected failures. The problem is solved by constructing the finite element model of the structure's problem element and analyzing its strain-stress state under various loading conditions using the module Structure 3D CAE-system APM WinMachine and comparing these results with the analysis of full-scale samples. In order to determine the geometric parameters of the structure input elements, as well as to adequately model the fixation of the interested part and the correct load application a 3D model of the assembly unit can be used. As a result of our calculations it is found that the reason for sudden destruction of the disk header's spring tines is the resonance with the torsional vibrations of the workpoint spring tine at the operating speeds of the unit. For finding engineering solutions to prevent the resonanc

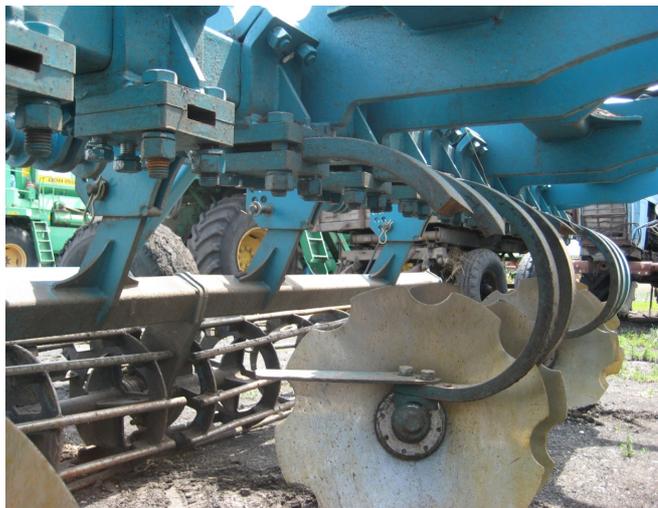
Exploitation of the prototype of a two-row trailed disk aggregate has shown good workmanship and strong characteristics: however, when the machine moves in the working position at speeds close to the maximum one, specified by the manufacturer ($15-17 \text{ km}\cdot\text{h}^{-1}$) [3; 4], destruction of spring tines can be observed, Fig. 1.

Fig. 1. Destruction of disk spring tines

The only regularity, which could be truly established, was the one concerned with the breaking point. Destruction occurred at the distance of 120-250 mm from the attaching point of the spring tine to the machine frame.

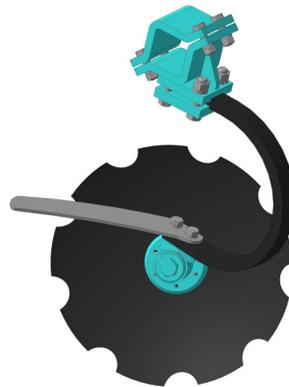
Based on the full-scale measurements, as well as the manufacture's technical documentation, in KOMPAS 3D we have built 3D models of all parts and modeled the whole assembly unit (Fig. 2).

Fig. 2. Assembly unit 3D model

The assembly unit model is important not only from the point of view of its part geometry, but also to adequately model the fixed part and the correct application of load.

The workpoint of the disk header is a cut-out disc with a diameter of 600 mm (Fig. 2) with a number of cuts $z = 9$.

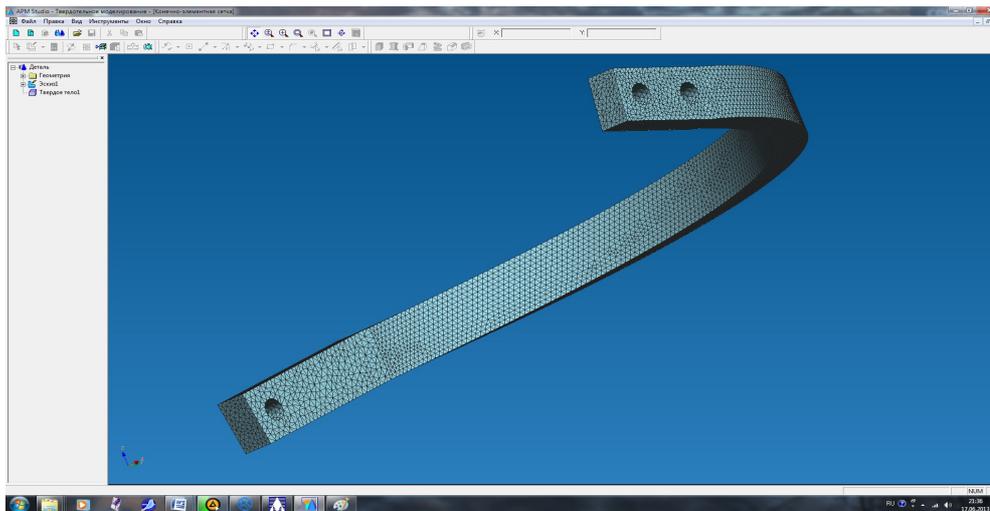
For calculation, first of all, it is necessary to construct finite element mesh of the part [6]. This operation was done in the APM Studio APE WinMachine CAE-system using the 3D model of our object (Fig. 3).

The final structure is quite regular and the parts have 8 layers of thickness and there is no collapsing of small gills. This allows to expect a good convergence and sufficient accuracy of the model calculation [5; 7].

Fig. 3. Finite element grid of spring rack

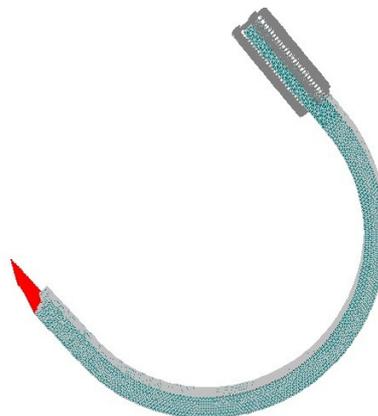
The design model was formed in the APM Structure 3D module. The research of construction of the tine attachment point to the machine frame has found that an adequate fixing model is an “anchorage” fixation. Thus, the fixation of the anchorage type was done for all nodes of the finite element mesh, located on the upper and lower edges of the straight part at the length of 170 mm (Fig. 4). We modelled the loading from the disk node point by the distributed load along the surface bottom of the straight section with two holes, in which the cutting unit is attached (Fig. 4).

The amount of effort applied to each node is determined from the total traction resistance of the disc header, which was found in traction tests and the vertical load represents the whole machine

gravity spread out over all workpoints. Thus, the horizontal force to the tine should be 3500 N and the vertical force should be 900 N.

Fig. 4. Design model

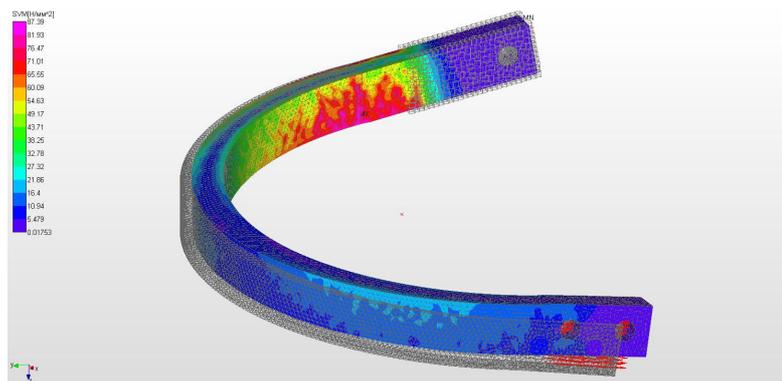
In the Structure 3D Module of CAE-system APM WinMachine we have done a static calculation, stability calculation and determination of the structure eigenfrequency. As a result, we have got strain-stress state of the tine (Fig. 5), which analysis showed that the construction design has a sufficient static strength (stock ratio 4.5) and endurance limit (endurance factor indicator is 2.3).

Therein the zone of maximum stresses is localized, where destruction occurs most often, but the nature of destruction of full-scale samples is definitely not static, so static strength exhaustion is not the cause of destruction.

Fig. 5. Stress distribution in tine of workpoint

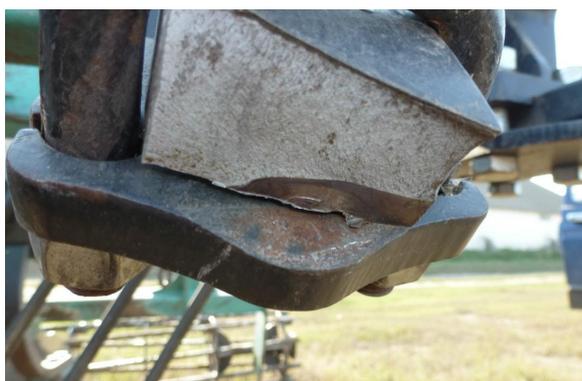
Prop distortion demonstrates signs of fatigue failure (Fig. 6) [8], but the nature of this crack is not answerable to the tine loading scheme; so the obtained safety factor is considered as an adequate one. In this case the cause of structural failure may be technological defects or material defects.

Fig. 6. Prop distortion

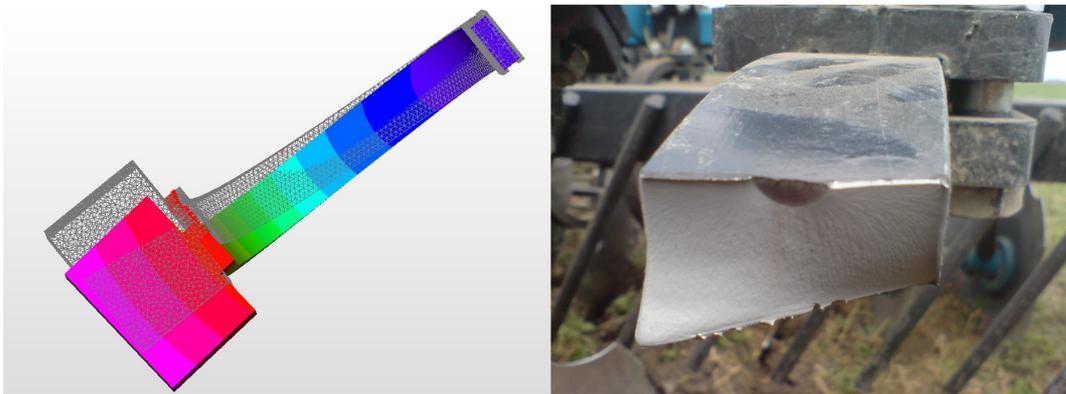
The second natural frequency corresponds to the torsional vibrations of the workpoint around the axis, which passes through the tine's mounting portion (Fig. 7).

Fig. 7. Form of spring tine and breaking point

The research of prop distortion (Fig. 7) shows that the development of a fatigue crack begins in the middle of a long face of a rectangular cross-section, i.e. it occurs in the action zone of maximum tangential stresses, which fully corresponds to the fatigue fracture in torsion [9]. The evaluation of other broken tines (Fig. 1) confirms our hypothesis: because most of the distortion sites are inclined at an angle of 45° , which is also typical for torsional fracture [10].

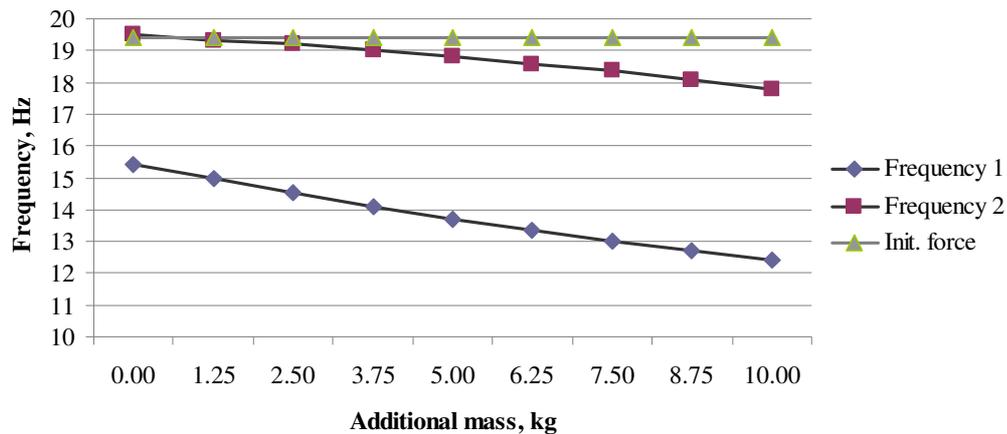
Therefore, we have researched the increase effect in mass (for example, additional load adding) of the elastic tine on the structure natural frequencies (Fig. 8).

Fig. 8. Natural frequencies dependence on additional mass (operating speed $14.5 \text{ km}\cdot\text{h}^{-1}$)

According to the research results for resonance prevention it is recommended to put additional mass of 8.5-9.0 kg on the disk body and simultaneously put the lower limit of the aggregate's operating speed at least 14.5 and not more than $15.5 \text{ km}\cdot\text{h}^{-1}$.

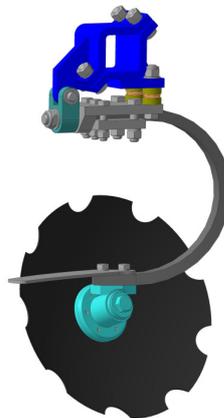
In CAD-system KOMPAS 3D the design of anchors of the disk workpoint was made, which prevents resonant phenomena (Fig. 9). At the same time, tray type springs are used as elastic supports, which provide the required stiffness value with minimal displacements.

Fig. 9. Developed design

One can reduce the structure natural frequency by decreasing the unit stiffness [14]. Therefore, the easiest solution is to change the mounting scheme of the elastic tine with an additional spring linkage; in other words, to achieve the effect that is necessary to get rid of anchorage by adding two additional elastic supports and simultaneously releasing two rotational degrees of freedom in the damaged tine plane.

Numerical experiments of the proposed scheme have found that optimal stiffness of supports is in the range of $1300\text{-}1600 \text{ N}\cdot\text{mm}^{-1}$.
