IDENTIFYING CAUSES OF ACCIDENTS AT LEVEL CROSSINGS

Michal Ballay, Eva Sventekova, Ludmila Macurova, Ladislav Imrich

University of Zilina, Slovakia

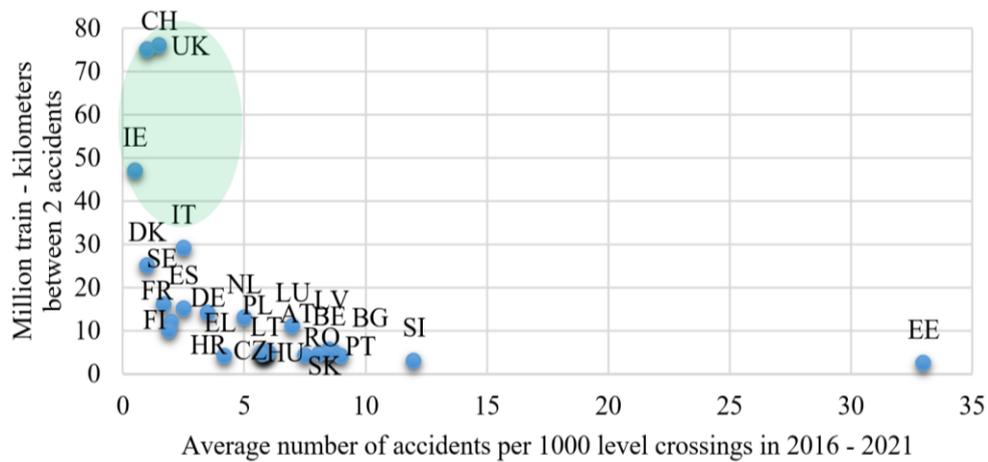
Fig. 1. Assessment of level crossings in ERA countries [3]

Safety can be measured at the same time by a combination of two indicators – the number of accidents per thousand crossings and one million train kilometers. Figure 1 shows these two indicators for the period 2016-2021, in each ERA (European Union Railway Agency) country. A high degree of security is marked in green, what expresses that there is a low number of accidents at level crossings in a given country and at the same time the number of train kilometers traveled between two accidents is as high as possible. Within the European Union, the Slovak Republic ranks to member states with more accidents per million train-kilometers.

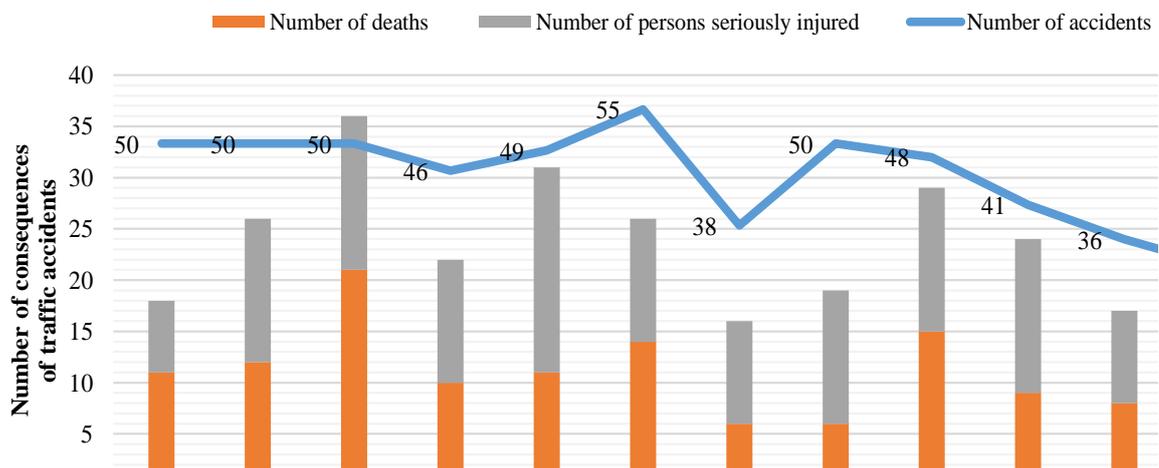
Fig. 2. Number of traffic accidents and the number of their consequences at railway crossings [7]

Accidents at railway crossings in the Slovak Republic have recorded a stagnant number in recent years, but their consequences are much more severe in the number of participants killed and seriously injured. A more detailed overview of the number of accidents and their consequences is shown in Figure 2. The human factor has the largest share in the occurrence of various accidents at railway crossings, as traffic behavior is influenced by many external and internal factors.

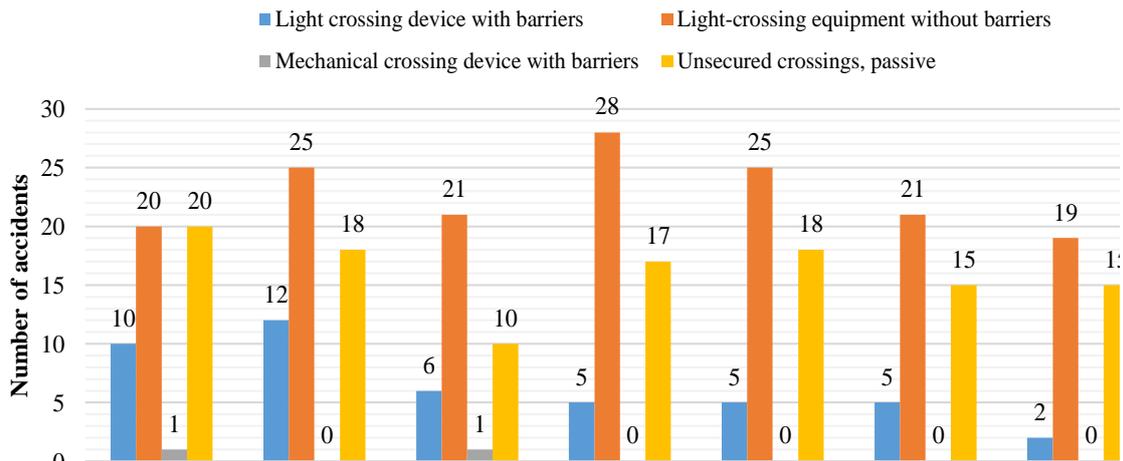
Fig. 3. Number of accidents by type of level crossing security [7]

The available accident statistics show that the vast majority of accidents occurred at active level crossings (especially at level crossings of roads and railways), which were secured only by traffic lights. Active railway crossings with light and mechanical security devices can be described as the safest. A more detailed overview of the number of accidents according to the type of security at the level crossing is given in Figure 3.

According to the figure, it can be further stated that the number of accidents at level crossings with light or mechanical barriers is much lower than the number of accidents at level crossings, without barriers. The reason may be the so-called barrier as a physical barrier for road vehicle drivers compared to traffic lights, which can be easily overlooked by drivers if they do not respect traffic rules.

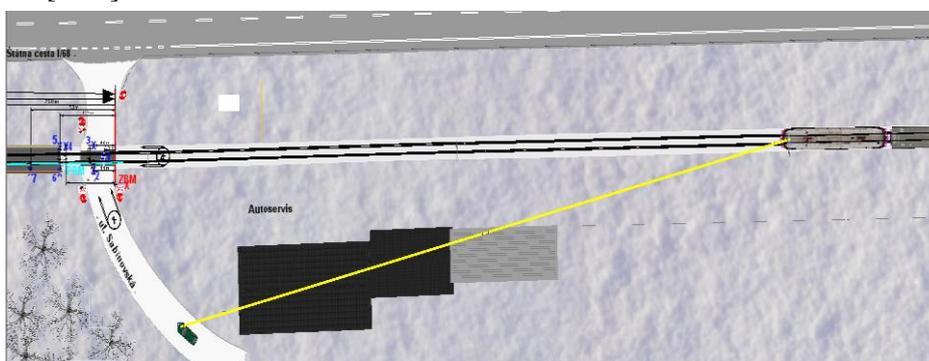
Fig. 4. Mutual position of vehicles in time 5s before the collision – 2D view

At the time of 5 seconds before the collision, the passenger train was located approximately 139 m from the railway crossing and was traveling at a speed of approximately $84 \text{ km}\cdot\text{h}^{-1}$. The driver of the road vehicle was located approximately 30 m from the railway crossing (near the car service building) and moved at a speed of approximately $25 \text{ km}\cdot\text{h}^{-1}$. From this point on, the driver of the vehicle did not have direct supervision of the passenger train.

Subsequently, the simulation of the accident took place with the mathematical - simulation program PC-Crash 13.1. The following part of the article presents an analysis of the overall situation before the collision (mutual position of vehicles) using 2D and 3D views (in the order of 5s, 2.5s, 1.5s before the collision and at the time of the collision).

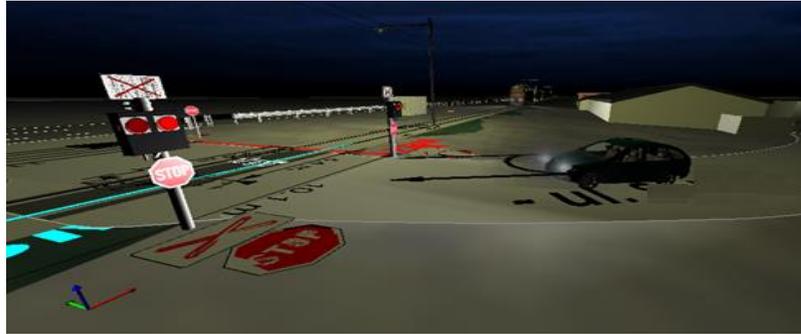
Fig. 5. Mutual position of vehicles 2.5 s before the collision – 3D view

At the time 2.5 seconds before the collision, the driver used an audible warning (as the beginning of the reaction to the development of the traffic situation), while the passenger train was located about 58m from the crossing and moved at a speed of about $84\text{km}\cdot\text{h}^{-1}$. The driver with the vehicle was located about 10 m in front of the crossing and moved at a driving speed of about $19 \text{ km}\cdot\text{h}^{-1}$.

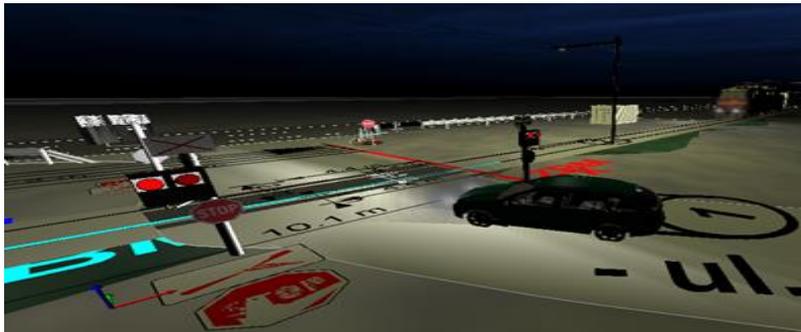
Fig. 6. Mutual position of vehicles 1.5 s before the collision – 3D view

At the time of 1.5 seconds before the collision, the passenger train was located about 34 m from the railway crossing and moved at a speed of about $84 \text{ km}\cdot\text{h}^{-1}$. The driver began to brake the train with rapid braking. The driver of the road vehicle was located about 3 m from the railway crossing and moved at a speed of about $17 \text{ km}\cdot\text{h}^{-1}$. He did not react to the given traffic situation and continued to drive through the railway crossing, despite the warning.

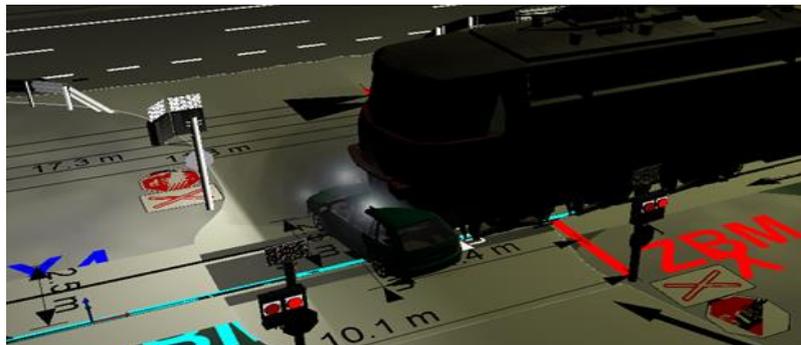
Fig. 7. Mutual position of vehicles at the time of the collision – 3D view

The relative position of the vehicles at the time of the collision is shown in Figure 7. From a technically acceptable calculation of the accident, it is most likely that the collision between the road vehicle and the passenger train occurred at the moment when the driver activated the rapid braking. The speed of the passenger train at the time of the collision was about $79 \text{ km}\cdot\text{h}^{-1}$ and the speed of the road vehicle at the time of the collision was about $13 \text{ km}\cdot\text{h}^{-1}$.

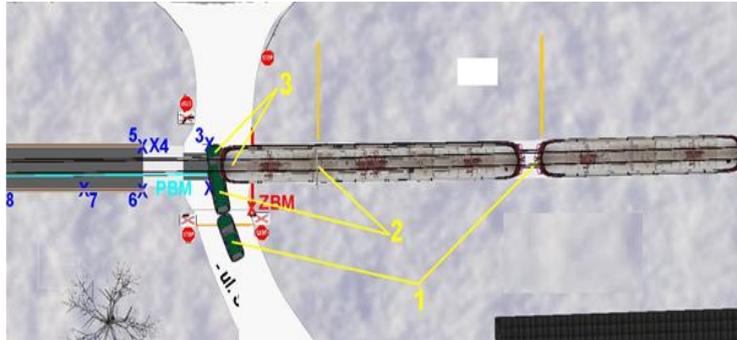
Fig. 8. Assessment of the technique of entering the road vehicle at the railway crossing:

The assessment of the technique of entering the road vehicle at the railway crossing is shown on Fig. 8.

1 – relative position of the vehicle and the locomotive at the moment of the beginning of the early reaction of the driver; 2 – mutual position of the vehicle and the locomotive at the moment of the onset of the braking effect of the train; 3 – mutual position of the vehicle and the locomotive at the moment of collision

By analyzing the accident, we did not find any circumstances that would prevent the driver at a sufficient distance from the crossing to see the incoming train and react correctly. Technically acceptable analyzes of the accident show that that the driver has technically created a sudden obstacle for the passenger train, because the passenger train could not be stopped in front of the collision site with the correct driving technique. We can therefore conclude that that the driver reacted to the situation in time, however, it would not be able to prevent a collision with the road vehicle even when using rapid-acting braking with maximum braking deceleration.

The technical cause of the accident in question was the incorrect driving technique of the vehicle driver (he did not pay full attention to driving the vehicle and did not sufficiently monitor the traffic situation). The result was his collision at a level crossing at a time when the crossing signaling device for its direction of travel signaled a warning with two red alternating “Stop” lights and at the same time the passenger train came to the railway crossing, thus creating a technical obstacle for the passenger train from a technical point of view. From the point of view of railway safety, it follows that that in the event of a collision between railways and roads, the railways always take precedence. A train like a multi-tone colossus cannot change the direction and its braking distance can be more than a kilometer depending on the speed and number of wagons. In the circumstances of the accident, it would clearly be appropriate that the railway crossing in question is fitted with barriers, or to reduce the maximum permitted speed of the passenger train [10; 11].
