DETERMINATION OF CAUSES OF SERIES ER2T ELECTRIC MULTIPLE UNIT TRAIN TRACTION GEAR RUBBER-CORD SHELL DAMAGE

Abstract. The theme of the article was chosen due to a large number of failures of the rubber-cord coupling for traction drive of ER2T series electric multiple unit (EMU) trains. The number of failures was summarized on the basis of the railway company JSC “Pasažieru vilciens”, operating on the Latvian railway, reports on unscheduled repairs for the period from 2015 till 2020. In the presented article we will discuss the determination of the reasons for ER2T series EMU trains rubber-cord coupling failure. The object under study was a rubber-cord coupling, which was out of order and taken after unscheduled repair from a motor car No. 2207-02. Based on the results of the test trial on 23.07.2020, the heating temperature of eight rubber-cord couplings was determined on four carriages of the ER2T series train No. 7115R on the route Riga-Jelgava. The shear stress τ_s and the radial load F_r acting on the coupling during movement are determined. In the RTU laboratory, the geometric dimensions of the coupling have been determined, the influence of the lubricant action and the temper

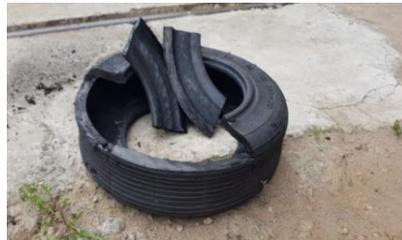
At the first stage, the geometric dimensions of the rubber-cord coupling were determined, the diameter of the outer surface of the coupling, the inner diameter and the thickness of the flange were determined, Fig. 4. To determine the geometric dimensions, two fragments were cut from the coupling.

Fig. 4. Preparation of the rubber cord coupling for measurement
