ANALYSIS AND INVESTIGATION ON DEFECTS – DELAMINATION AND SPALLING OF METAL ON ROLLING SURFACE OF RAIL HEAD UNDER CODE X 10.1

Viktors Ivanovs, Pavels Gavrilovs
Riga Technical University, Latvia
viktors.ivanovs_2@rtu.lv, pavels.gavrilovs@rtu.lv

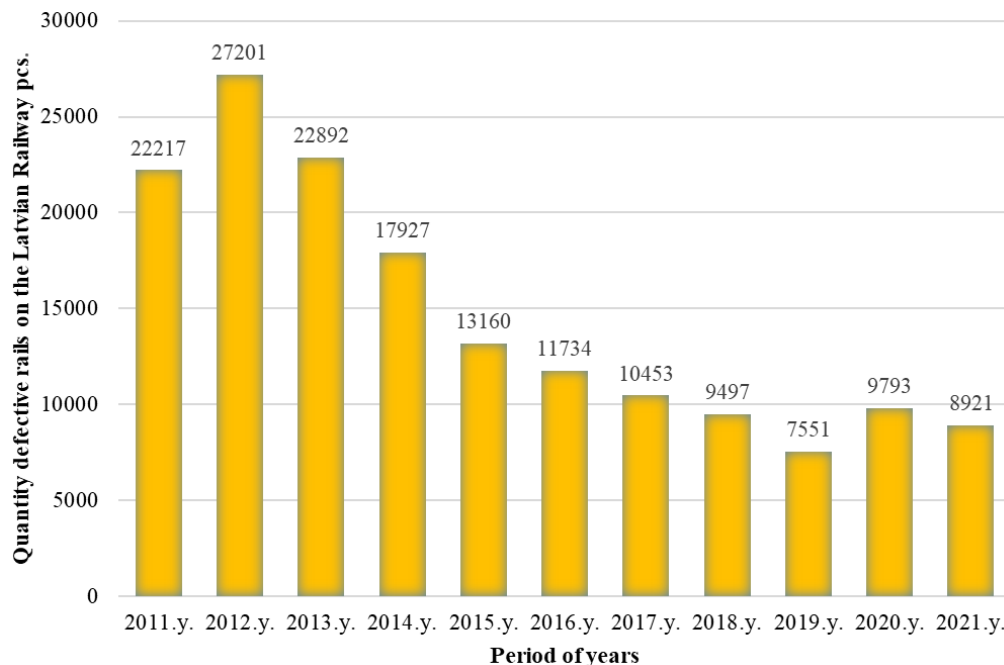
Fig. 2. Statistics of the total number of defective rails on the Latvian Railway from 2011 to 2021

From the provided analysis of defective rails shown in Fig. 2 in the period from 2012 to 2019, the number of defective rails on the Latvian Railway noticeably decreased from 27201 to 7551 [2]. The largest number of rail defects in the amount of 27201 was in 2012. In 2013 the number of defects decreased to 22892 cases. From 2014 to 2019, the number of defects has significantly decreased from 17927 to 7551, indicating that the first priority of the Latvian Railway is the safe and uninterrupted movement of trains at the established speeds. However, in 2020 the number of defective rails increased to 9793 and decreased slightly in 2021 to 8921 cases [2].

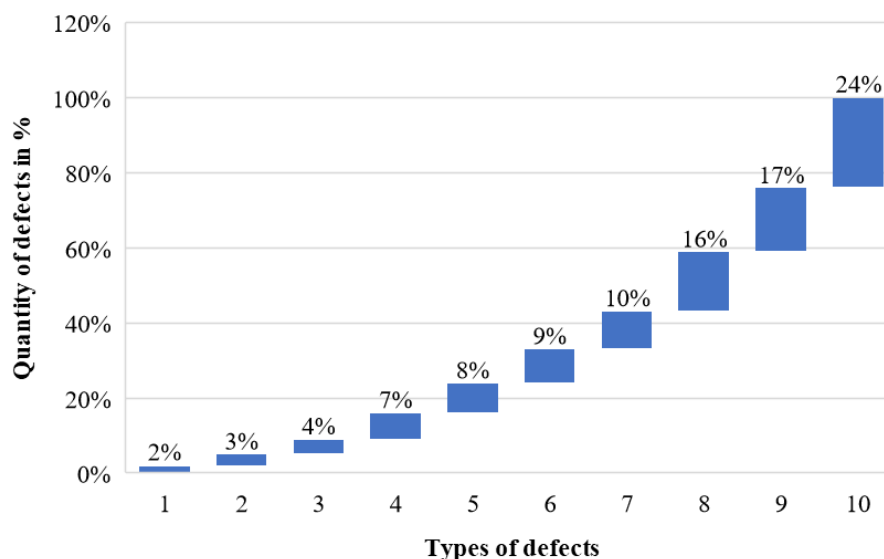
Fig. 3. **Statistics of defective rails on the Ukraine Railways in 2021:** 2% – defective rails under code X 43.1; 3% – defective rails under code X 99.0; 4% – defective rails under code X 18.1-2; 7% – defective rails under code X 11.1-2; 8% – defective rails under code X 17.1-2; 9% – defective rails under code X 44.0; 10% – defective rails under code X 41.0-1-2; 16% – defective rails under code X 10.1-2; 17% – defective rails under code X 14.0-1-2; 24% – defective rails under code X 46.3-4

From the statistics of defects for 2021 on the Ukraine railways, the main defects are defects under the codes X 46.3-4 smashing and vertical wear of the rail head in the welded joint area (24%), X 14.0-1-2 wheel slip impact in the form of local wear and spalling of metal in places of the more mechanical damage to the rail head (17%) and X 10.1-2 cracks and spalling of metal on the surface of the head tread (16%). 10% of defects under the X 41.0-1-2 code are smashing and vertical wear of the rail head [6]. One of the most common defects on the railways of the world is a defect under the code X 44.0 lateral wear of the railhead exceeding the permissible norms, which makes up 9% of the total number of defective rails on the Ukraine railways. No less important is the defect under the code X 17.1-2 of metal spalling on the head rolling surface, which is 8%. The defect code X 11.1-2 cracks and metal spalling on the side working fillet on the middle part of the rail head is 7%. Defects - spalling of the deposited metal layer in the places of surfacing under the code X 18.1-2 make up 4% of the total statistics, and other than listed above defects under the code X 99.0 are relevant on Ukraine railways. 2% – defective rails under the code X 43.1, smashing of the head in the form of a saddle in the area of the bolted joint [7], are detected on the Ukraine railways. This statistic once again confirms the actuality of the problem of defective rails in the head and on the rolling surface both on the Latvian railway and on foreign railways [8].
